TECHNICAL MEMORANDUM

Subject: East Hampton Airport Noise Mitigation Program
Preliminary Results of the Noise Measurement Program;
Phase II – August 21st to September 2nd 2003

Preliminary Results of the Noise Measurement Program: Phase II
July 8, 2009
Page i

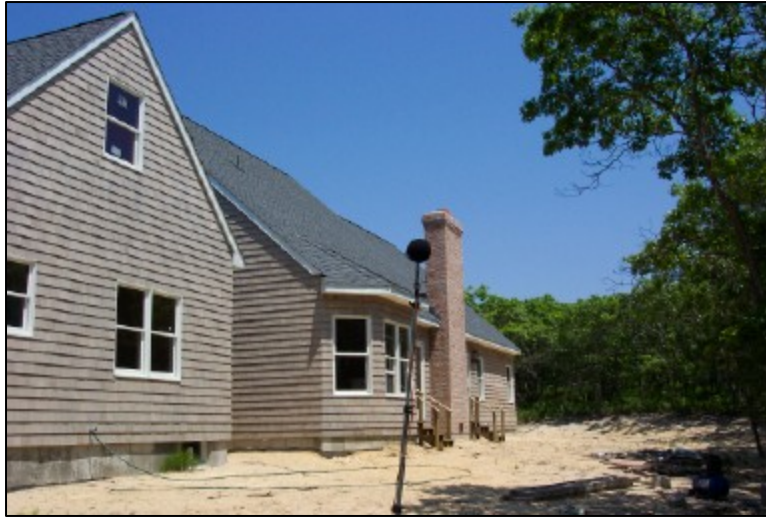
Figure 1. Microphone Location for Site 1

Site 1 was located in the backyard of a single-family home located at 11 Highview Drive in Wainscott. This site was north of the airport, approximately 3200 feet from the end of Runway 16/34 and 1000 feet west of the extended runway centerline. Figure 1 shows the location of the microphone in the backyard of this residence.

Site 1 was selected to document helicopter traffic patterns and operations. The site is located roughly 500 feet north of a power line that is used as a reference for helicopter pilots on approach to Runway 16.

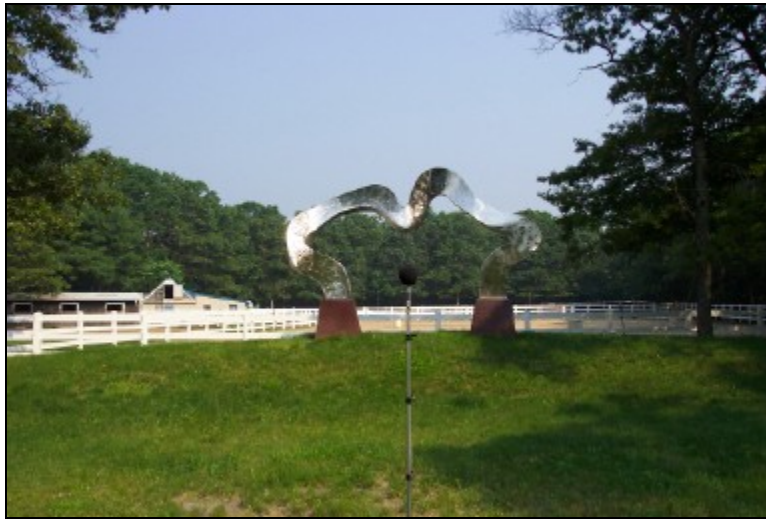
Figure 2. Microphone Location for Site 2A

Site 2A was located in the yard of a single-family home located at 93 Merchants Path. This site was situated west of the airport, approximately 5200 feet from the end of Runway 10/28 and 1700 feet south of the extended runway centerline. Figure 2 shows the location of the microphone in the front yard of the residence at 93 Merchants Path.

Site 2A was selected to obtain noise levels and document aircraft operations from Runway 10/28. Attended noise measurements were conducted on August 22nd from 11:40 to 14:00, and on August 25th from 14:47 to 17:31. Appendix A provides graphs of the hourly noise levels for all sites, including the following noise metrics: L_{max} , L_{eq} , L_1 , L_{10} , L_{50} , and L_{90} .

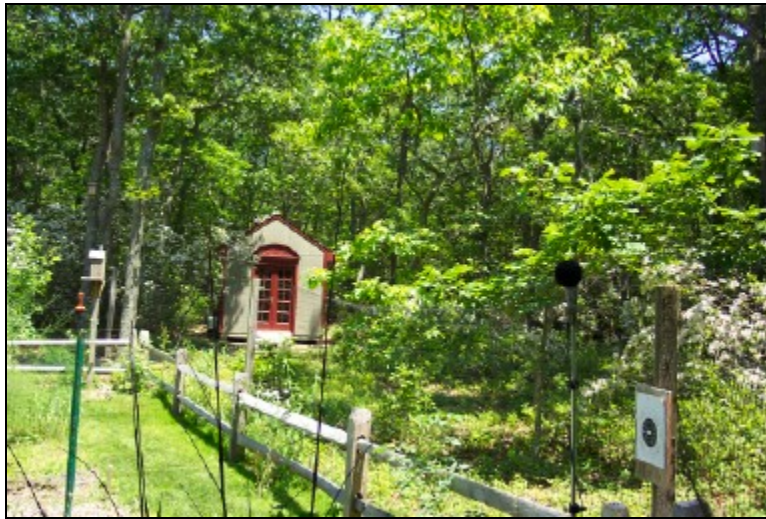
Figure 3. Microphone Location for Site 3

Site 3 was located in the backyard of a single-family home located at 244 Widow Gravitts in Bridgehampton. This site was northwest of the airport, approximately 7700 feet from the end of Runway 10/28 and 3200 feet north of the extended runway centerline. Figure 3 shows the location of the microphone in the backyard of this residence.

Site 3 also was selected to document helicopter traffic patterns and operations. The site is located roughly 500 feet south of a power line that is used as a reference for helicopter pilots on approach to Runway 16.

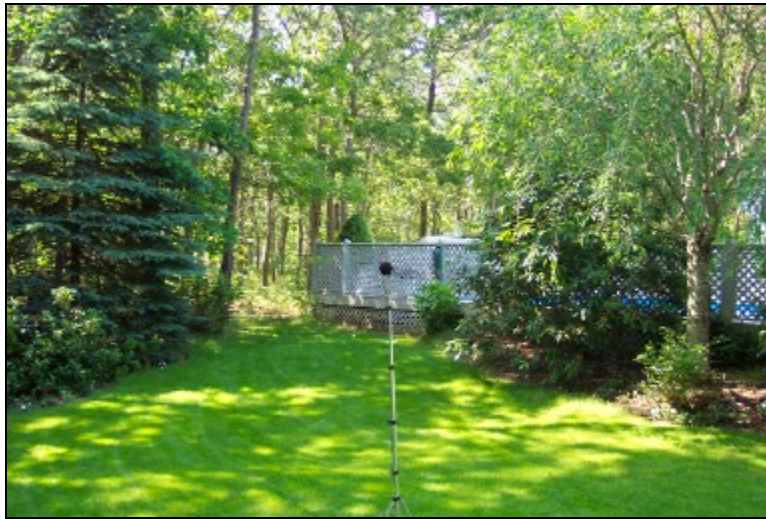
Figure 4. Microphone Location for Site 4

Site 4 was located in the backyard of a single-family home located at 75 West Gate in Wainscott. This site was south of the airport, approximately 1500 feet from the end of Runway 04/22 and 700 feet east of the extended runway centerline. Figure 4 shows the location of the microphone in the backyard of this residence.

Site 4 was selected to obtain noise levels and document aircraft operations to and from Runways 04/22 and 10/28. Attended noise measurements were conducted on August 22nd from 11:55 to 14:05, on August 26th from 09:40 to 12:40, and on August 27th from 09:53 to 13:23. Appendix A provides graphs of the hourly noise levels for all sites, including the following noise metrics: L_{max} , L_{eq} , L_1 , L_{10} , L_{50} , and L_{90} .

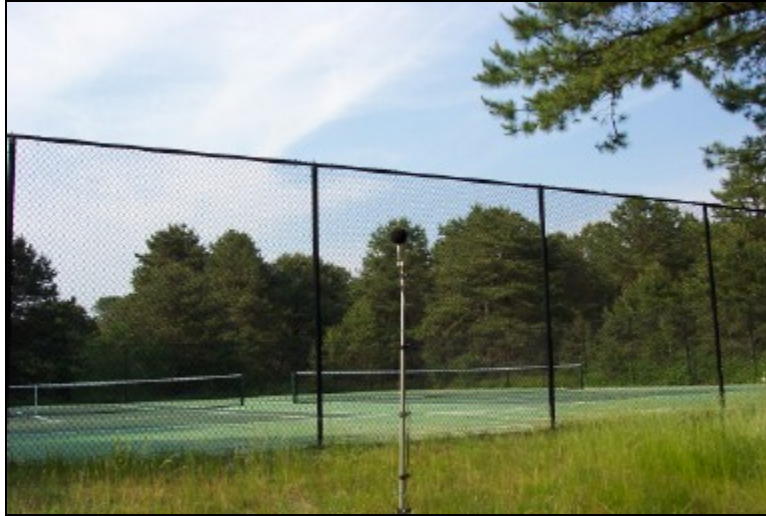
Figure 5. Microphone Location for Site 5

Site 5 was located near the tennis courts at Georgica Estates in East Hampton. This site was east of the airport, approximately 4700 feet from the end of Runway 10/28 and 500 feet south of the extended runway centerline. Figure 5 shows the location of the microphone in relation to the tennis courts.

Site 5 was selected to obtain noise levels and document aircraft operations to and from Runway 10/28. Attended noise measurements were conducted on August 22nd from 15:24 to 18:33, on August 26th from 15:43 to 17:01, on August 28th from 10:15 to 13:24, on August 30th from 09:47 to 11:54, on August 31st from 10:48 to 11:02, on September 1st from 11:15 to 14:05, and on September 2nd from 08:45 to 11:15. Appendix A provides graphs of the hourly noise levels for all sites, including the following noise metrics: L_{max} , L_{eq} , L_1 , L_{10} , L_{50} , and L_{90} .

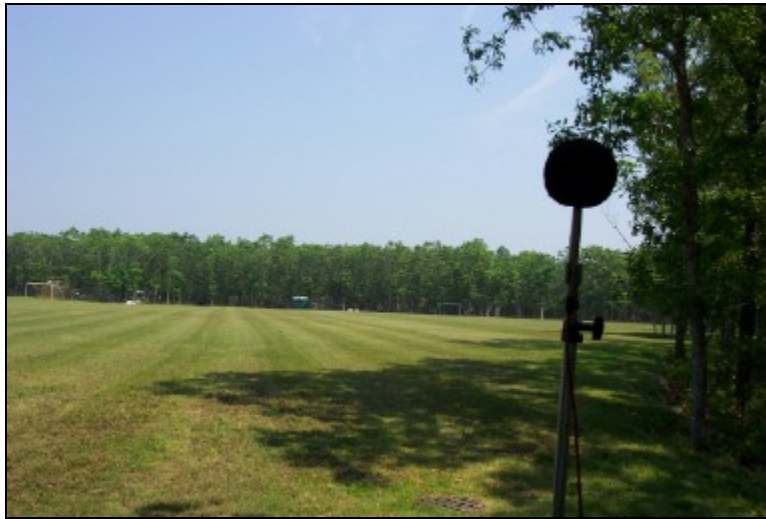
Figure 6. Microphone Location for Site 6

Site 6 was located near the athletic fields at the Ross School in Wainscott. This site was north of the airport, approximately 2000 feet from the end of Runway 04/22 and 600 feet east of the extended runway centerline. Figure 6 shows the location of the microphone in relation to the athletic fields for the Phase 1 measurements.

Site 6 was selected to obtain noise levels and document aircraft operations to and from Runways 04/22 and 16/34. Attended noise measurements were conducted on August 25th from 10:12 to 11:31, on August 26th from 09:24 to 12:27, and on August 27th from 10:13 to 11:37. Appendix A provides graphs of the hourly noise levels for all sites, including the following noise metrics: L_{max} , L_{eq} , L_1 , L_{10} , L_{50} , and L_{90} .

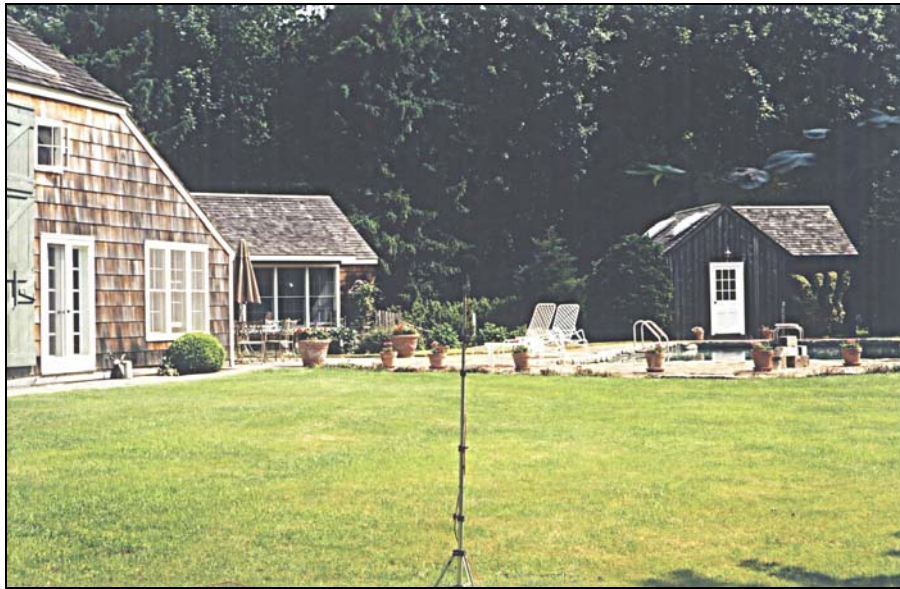
Figure 7. Microphone Location for Site 7

Site 7 was located in the backyard of a single-family home at 136 Main Street in East Hampton Village. This site was east of the airport, approximately 15000 feet from the end of Runway 10/28 and 500 feet south of the extended runway centerline. Figure 7 shows the location of the microphone in relation to the house.

Site 7 was selected to obtain noise levels and document aircraft operations for Runway 10/28. Attended noise measurements were conducted on August 27th from 16:22 to 18:53, on August 28th from 15:30 to 19:09, on August 29th from 16:15 to 18:12, on August 30th from 14:30 to 16:13, on August 31st from 16:30 to 17:55, and on September 1st from 17:40 to 19:00. Appendix A provides graphs of the hourly noise levels for all sites, including the following noise metrics: L_{max} , L_{eq} , L_1 , L_{10} , L_{50} , and L_{90} .
