## LAKE MONTAUK WATERSHED MANAGEMENT PLAN

**FINAL**

**December 2014**

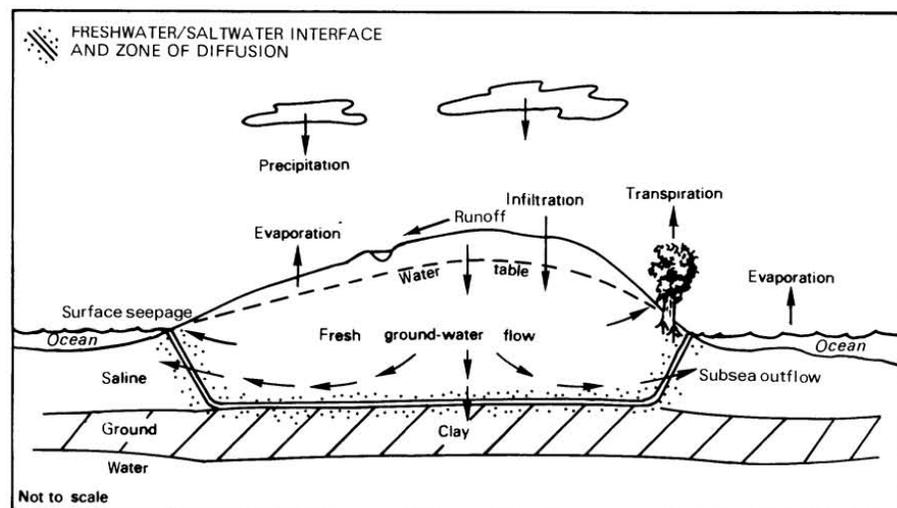
<sup>3</sup> Illustration from Simmons, 1986; Figure 4, Hydrologic cycle and pattern of ground-water movement.

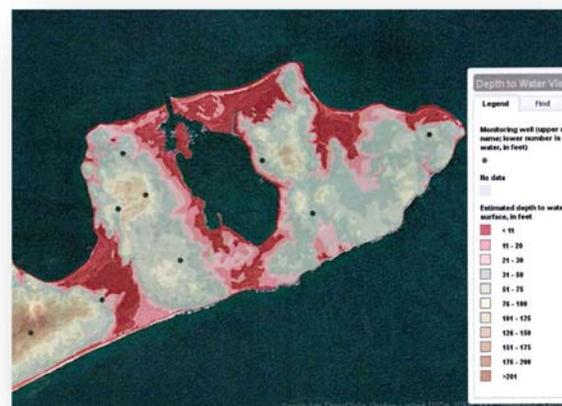
The USGS figure (embedded) and **Figure 8** illustrates the depth to water in the area of Lake Montauk, which ranges from approximately 0 at areas where surface waters are encountered to 146 feet at the high points of the watershed, located on the western and eastern sides of Lake Montauk. The red areas

<sup>4</sup> Illustration shows spring/fall groundwater levels, fresh-salt water mixing zone and outflow at shoreline.

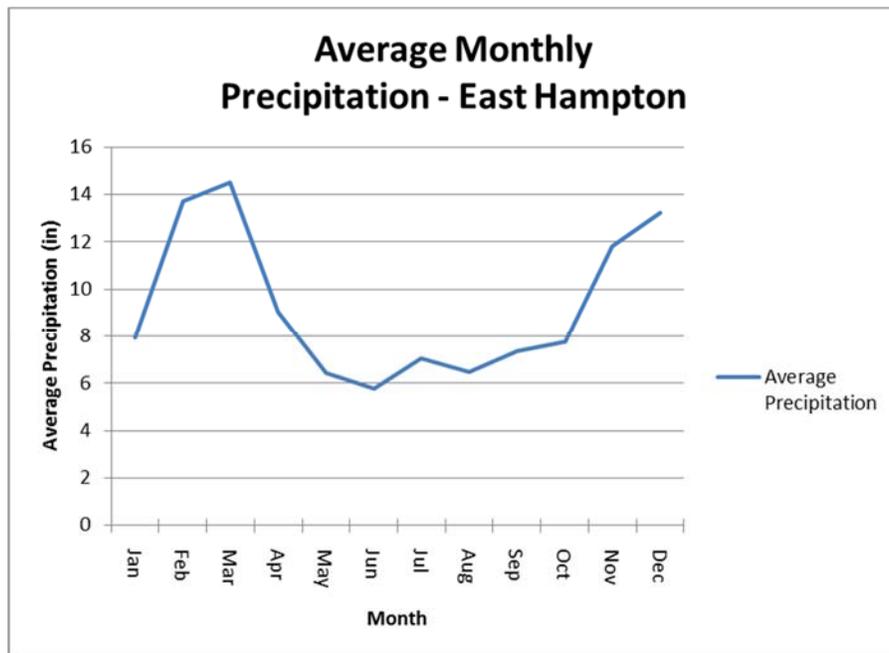
**Graph 1**  
**Average Monthly Precipitation – East Hampton**

As illustrated in **Graph 2**, annual total precipitation varies from year to year as a result of varying climate conditions. The dataset indicates that 2010 experienced the lowest quantity of precipitation, receiving only 62.66 inches of precipitation, while 2004 experienced the greatest quantity of precipitation, receiving 137.26 inches. The data illustrates that the short term trend for precipitation in East Hampton is a decline in annual precipitation; however, as the data is over a relatively short timeframe (nine years) this trend may not be representative of the overall long term precipitation trend experienced by East Hampton.

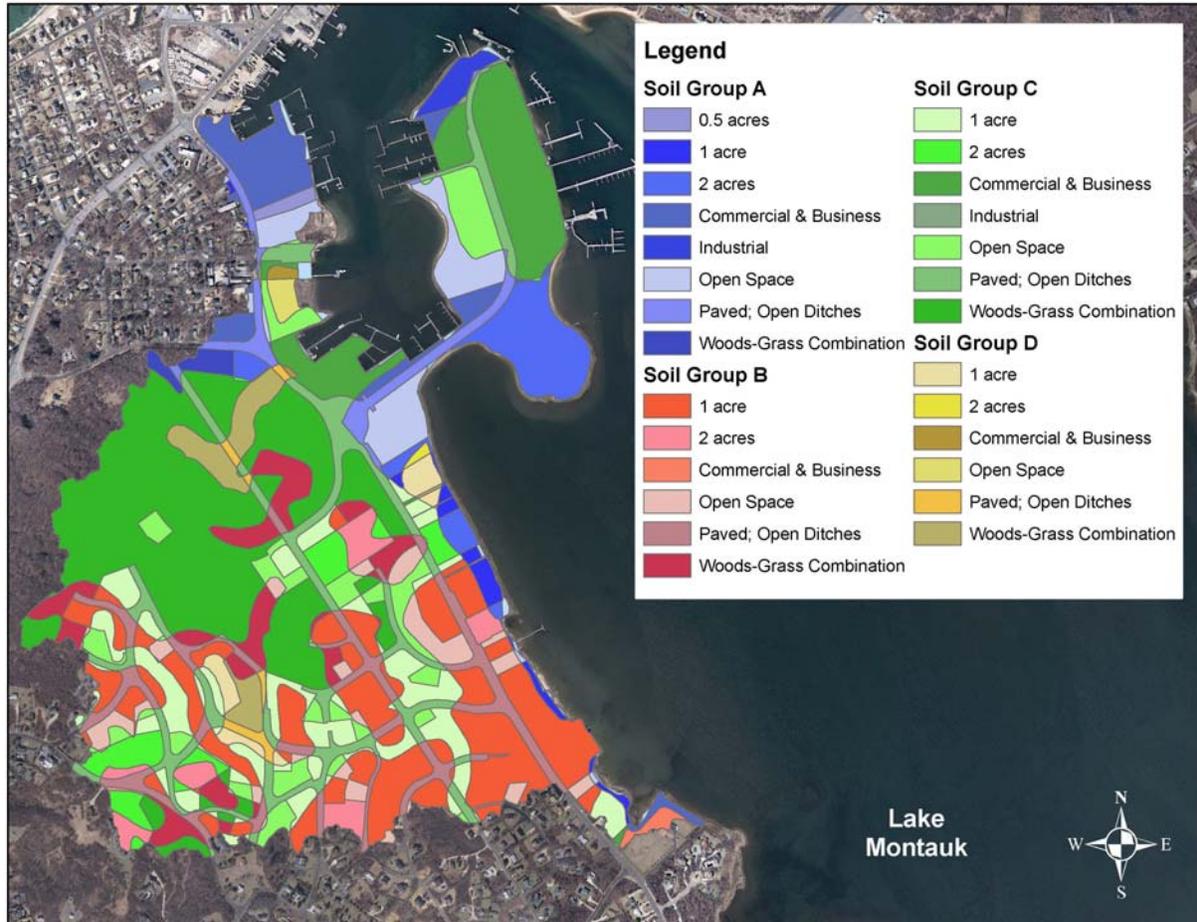
Figure 6 – Subwatershed 2 hydrologic soil groups and land use.

This is accomplished by cutting the land use layer with the hydrologic soil group layer. In this case, we end up with 27 unique combinations of land use and hydrological soil groups, as can be seen in Figure 6. The area is determined for each unique combination and the WinTR-20 software generates the curve number. The averaging of all curve numbers weighted by percent area allows WinTR-20 to calculate runoff. The above process was repeated for each subwatershed.

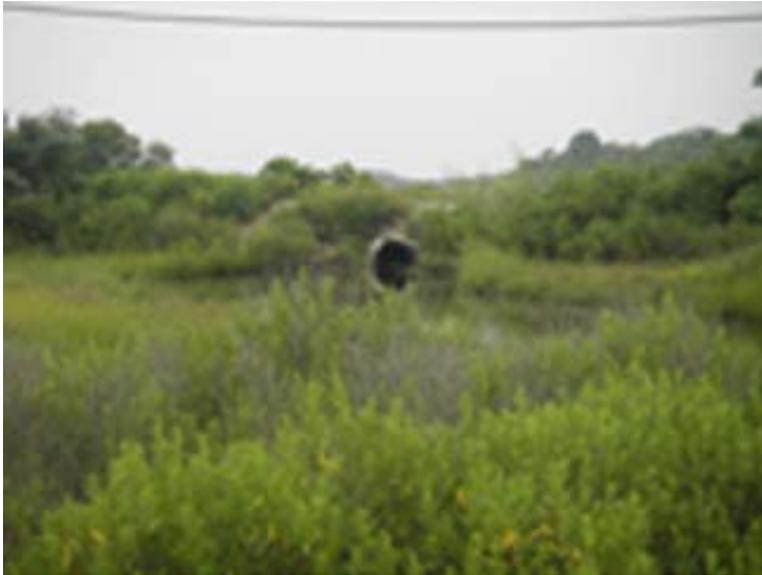
West side of East Lake Drive

**Location & Pipe Description:** 36 in pipe discharging water from Little Reed Pond. There is a stream channel located below the pipe.

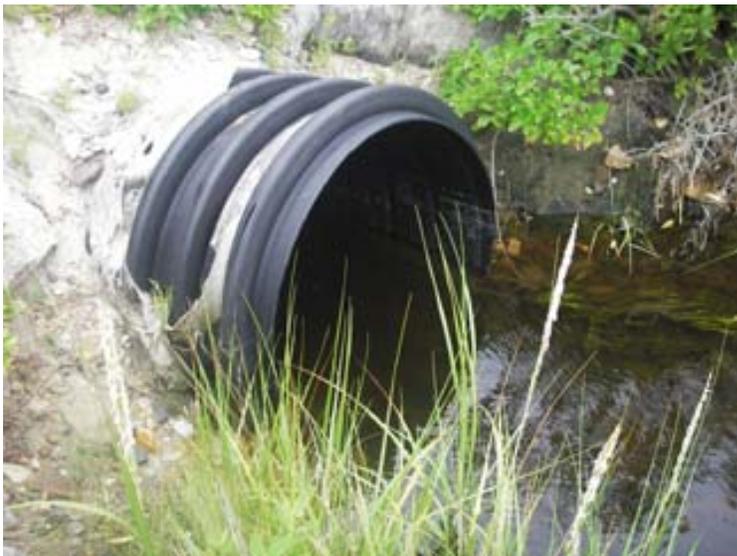
Pipe into Lake Montauk

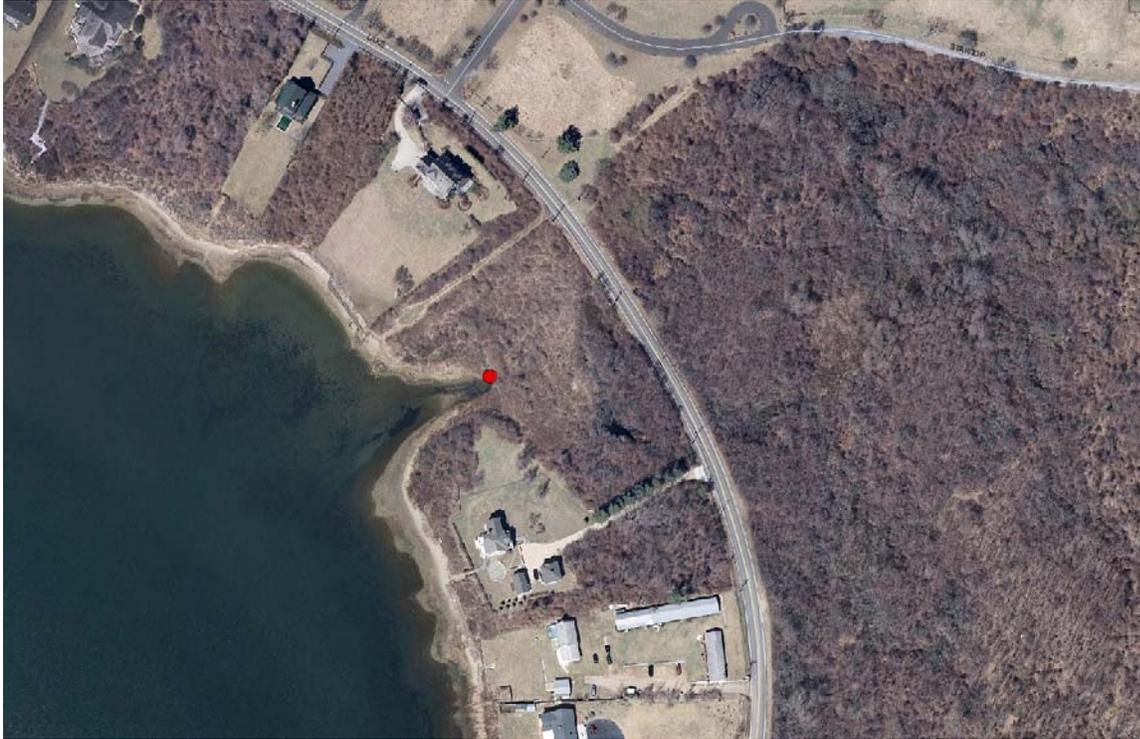
**Location & Pipe Description:** Pipe is located in a headwall. Retention Pond constructed June-July, 2010.

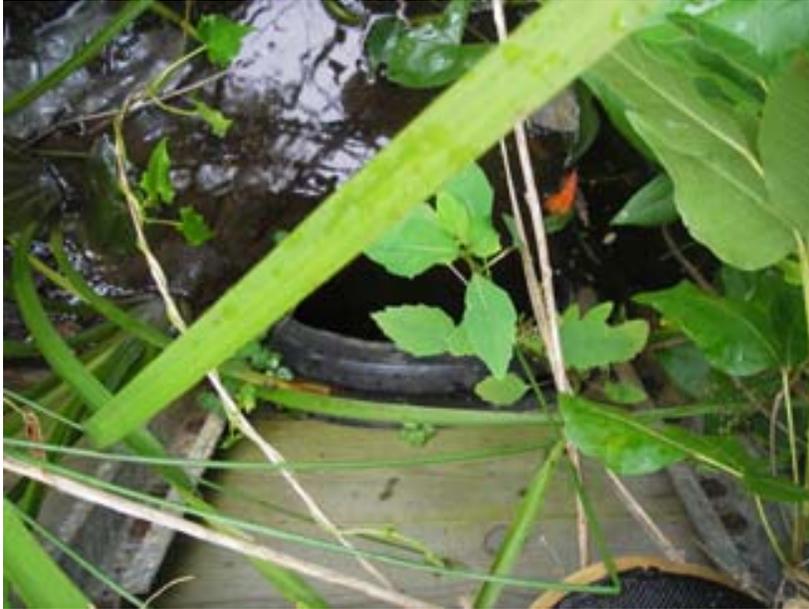
**Location & Pipe Description:** The pipe diameter was 12 inches. Channel present.

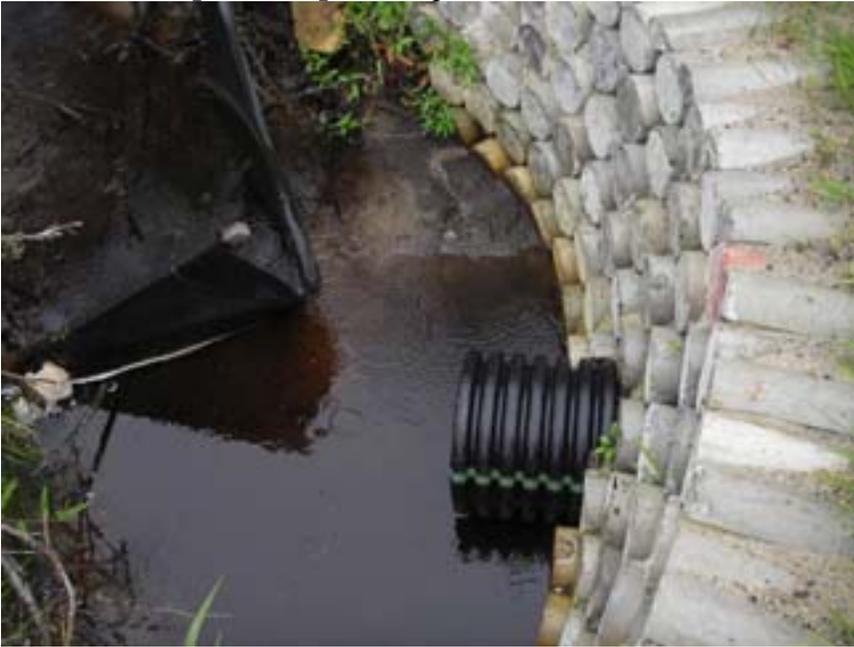
**Location & Pipe Description:** Pipe diameter is 12 inches.

Pipe on eastern portion of road.

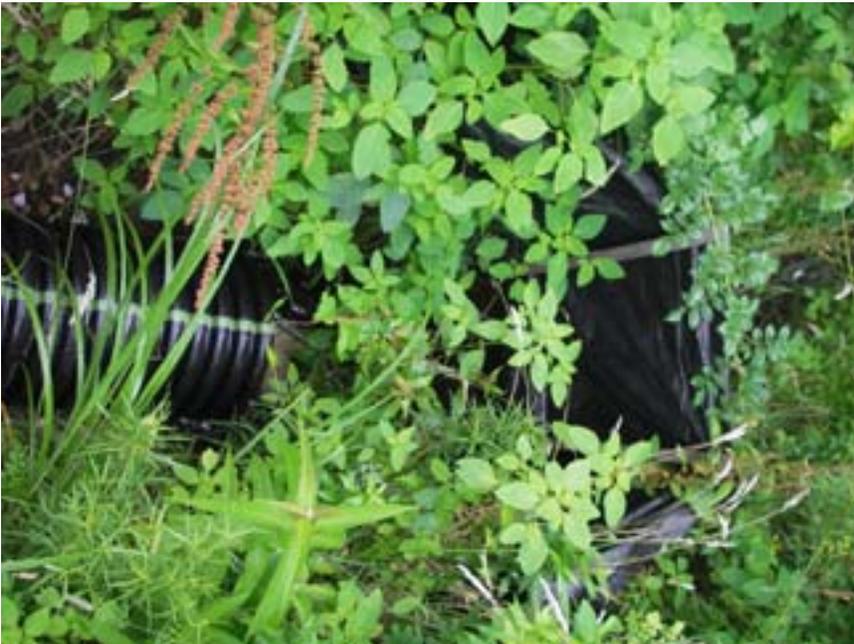
Pipe on western portion of the road. Note silt fence in front of pipe.

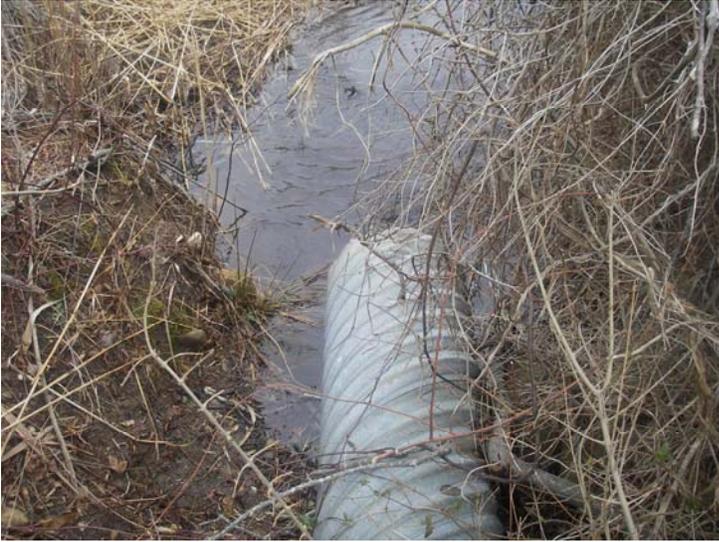
**Location & Pipe Description:** Two pipes found. One discharges directly into channel and the other is raised above the channel. The pipe that discharges into the channel was underwater and flowing. The pipe raised above the channel was dry. Water flows through wetland.

Pipe located above the channel.

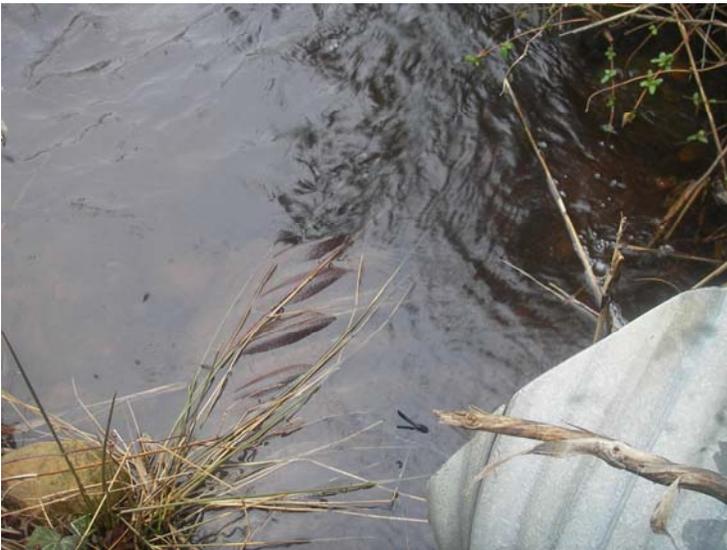
Pipe that discharges directly into channel.

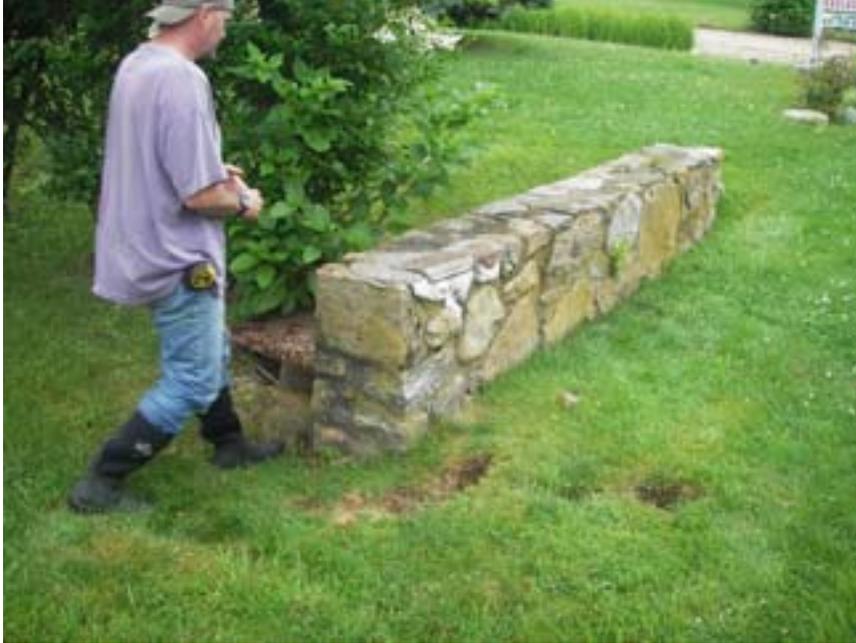
**Location & Pipe Description:** Have to lift cover to access pipe. Pipe approximately 16 inches. There is a channel across the street, but there is no pipe apparent.

Pipe located under cover to the left. There is no stream channel.

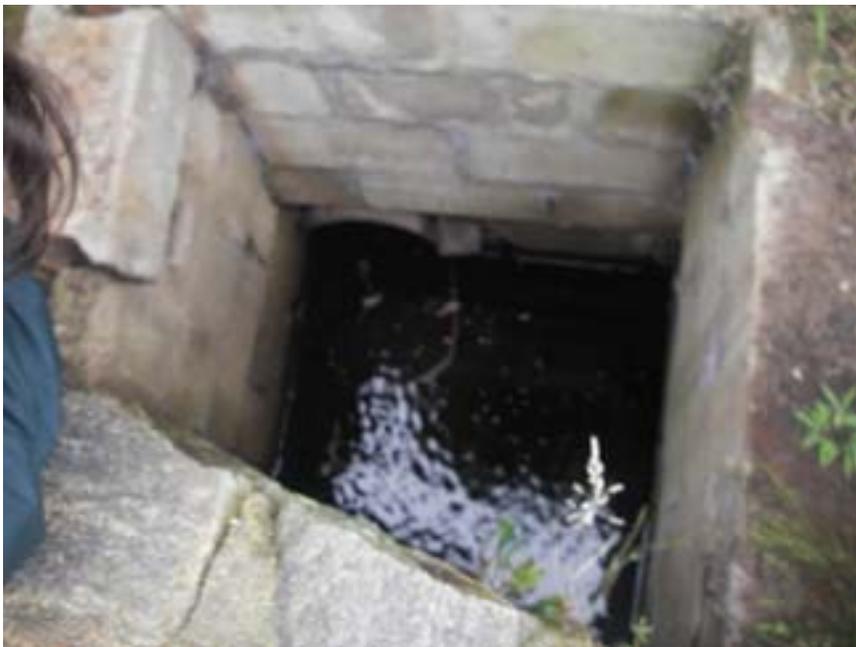
Looking down at pipe

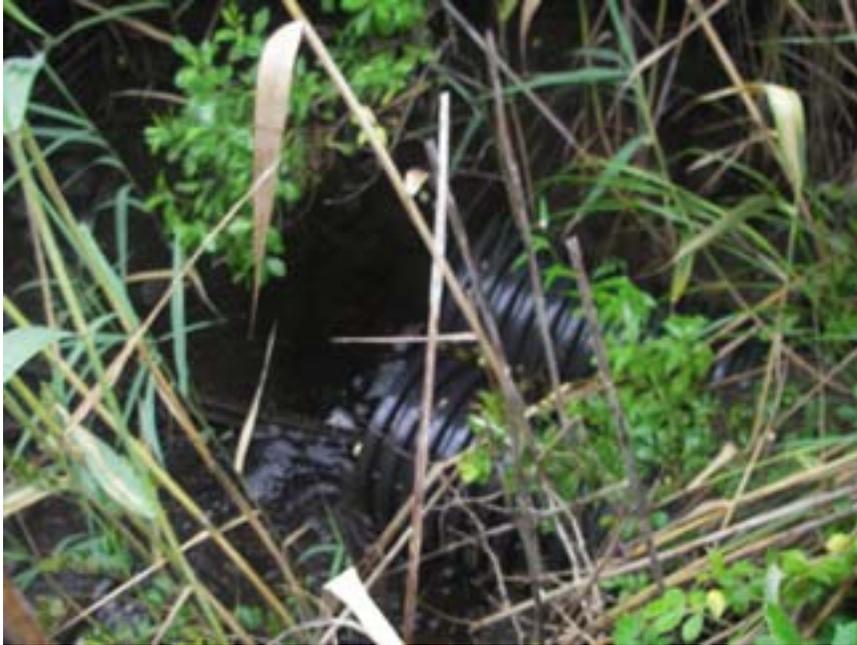
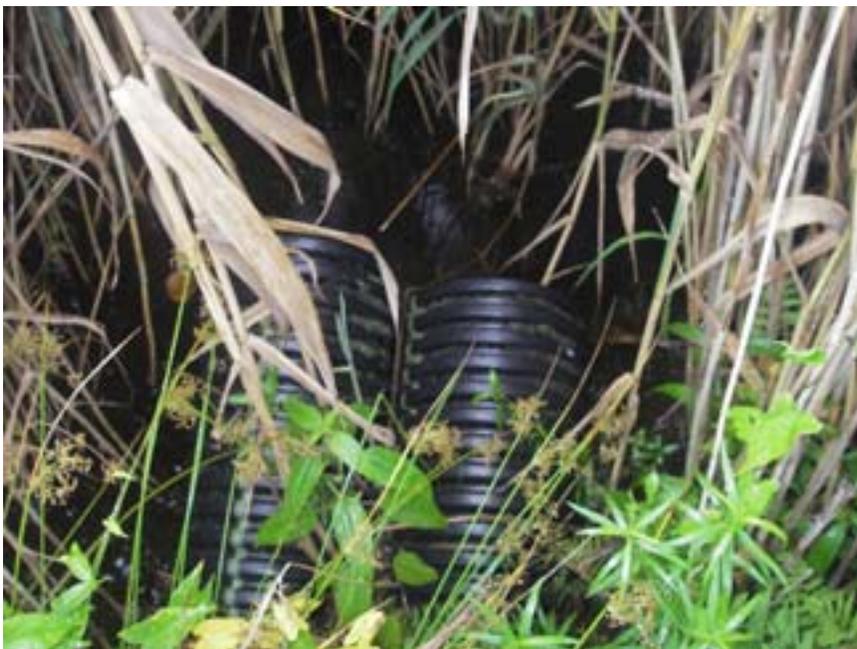
**Location & Pipe Description:** Pipes are two black 12 inch corrugated plastic.

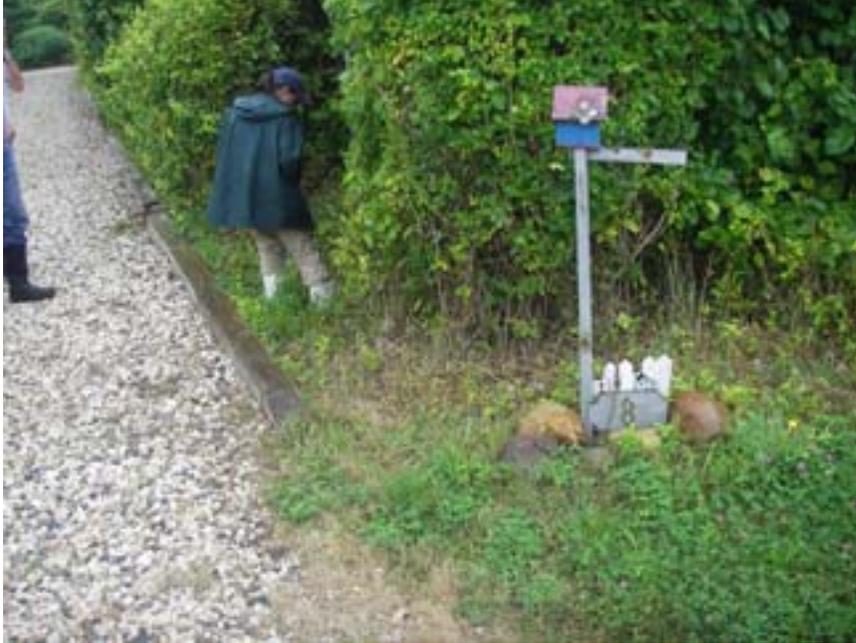
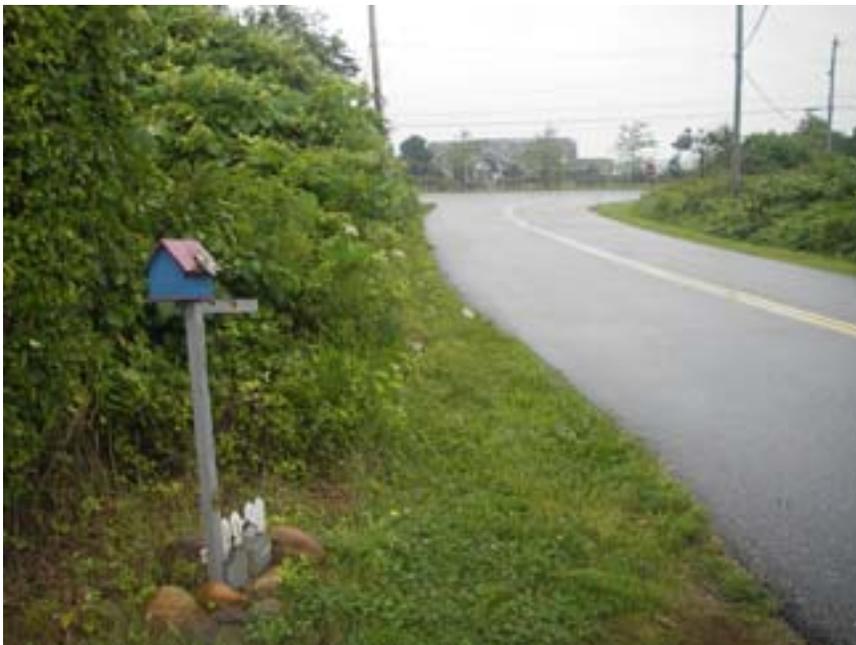
**Location & Pipe Description:** Pipe diameter is 24 inches. There is a creek that the pipe discharges into. The stream has a sandy bottom.

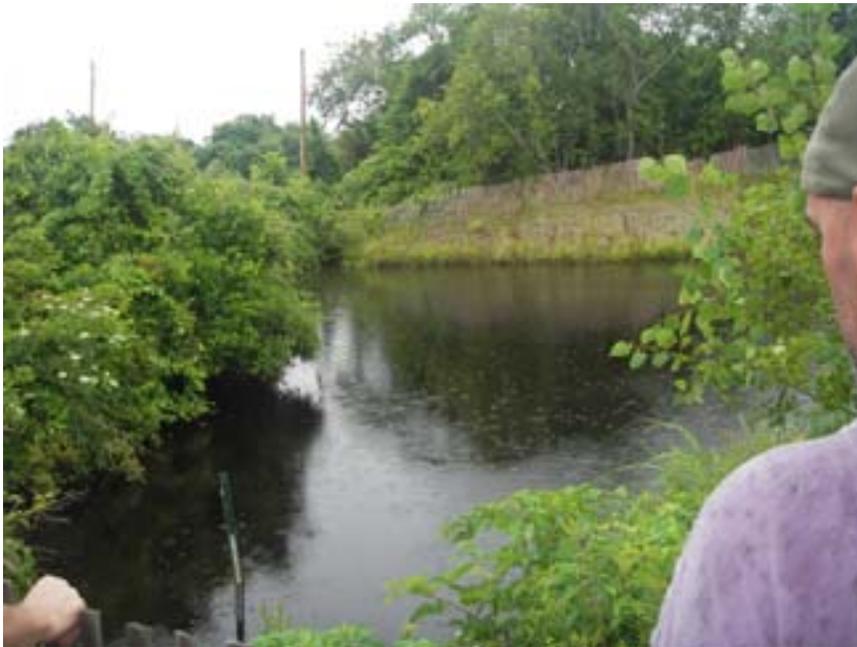
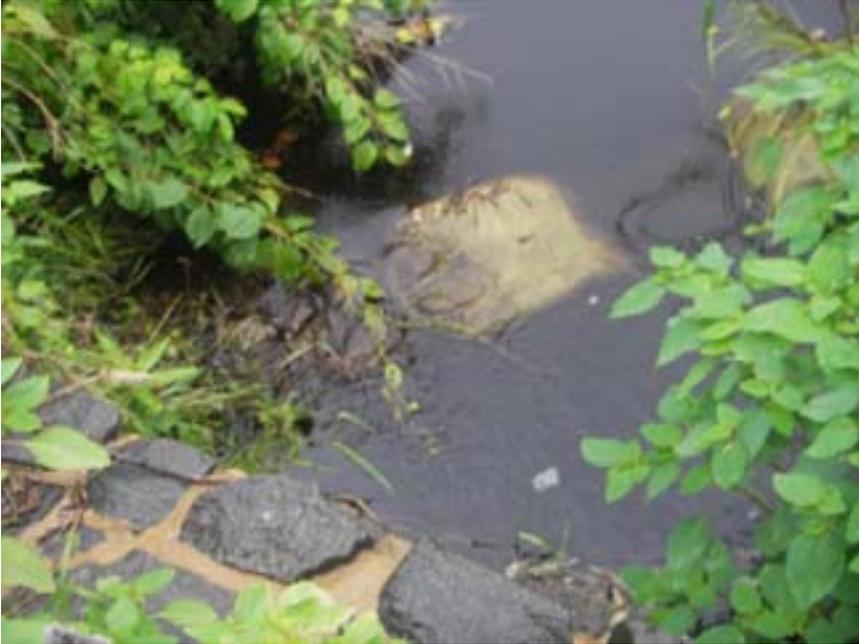
**Location & Pipe Description:** Discharge from the pond/lake.

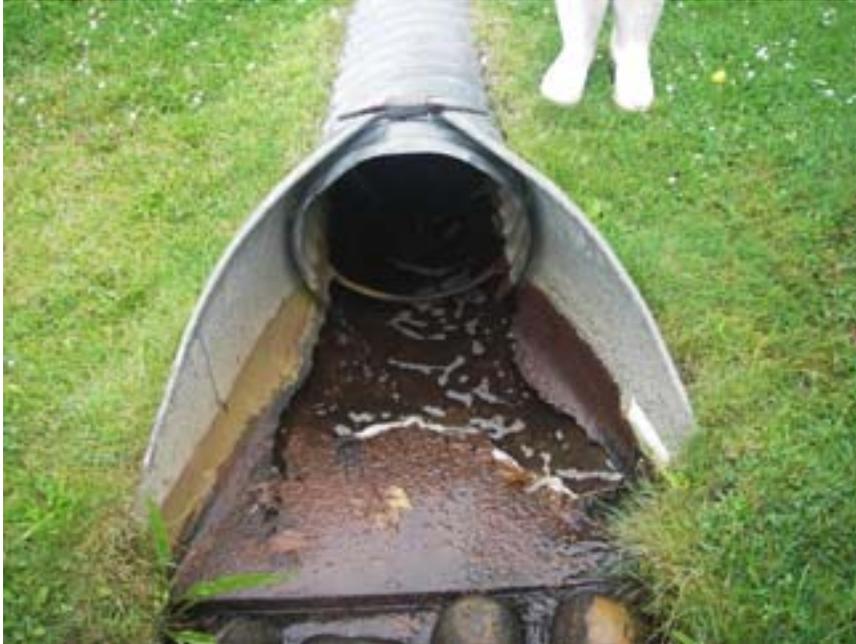
**Location & Pipe Description:** Pipe diameter is 18 inches. Pipe discharges directly to beach. No stream channel present.

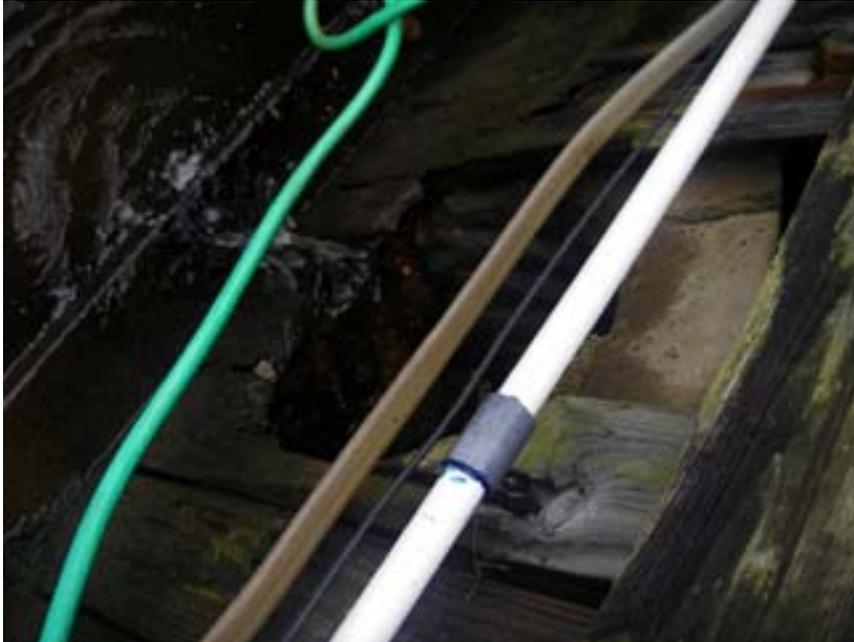
**Location & Pipe Description:** Outfall discharges directly into lake through bulk heading at Diamond Cove Marina. Pipe on other side of the street is 16 in and has a small channel.

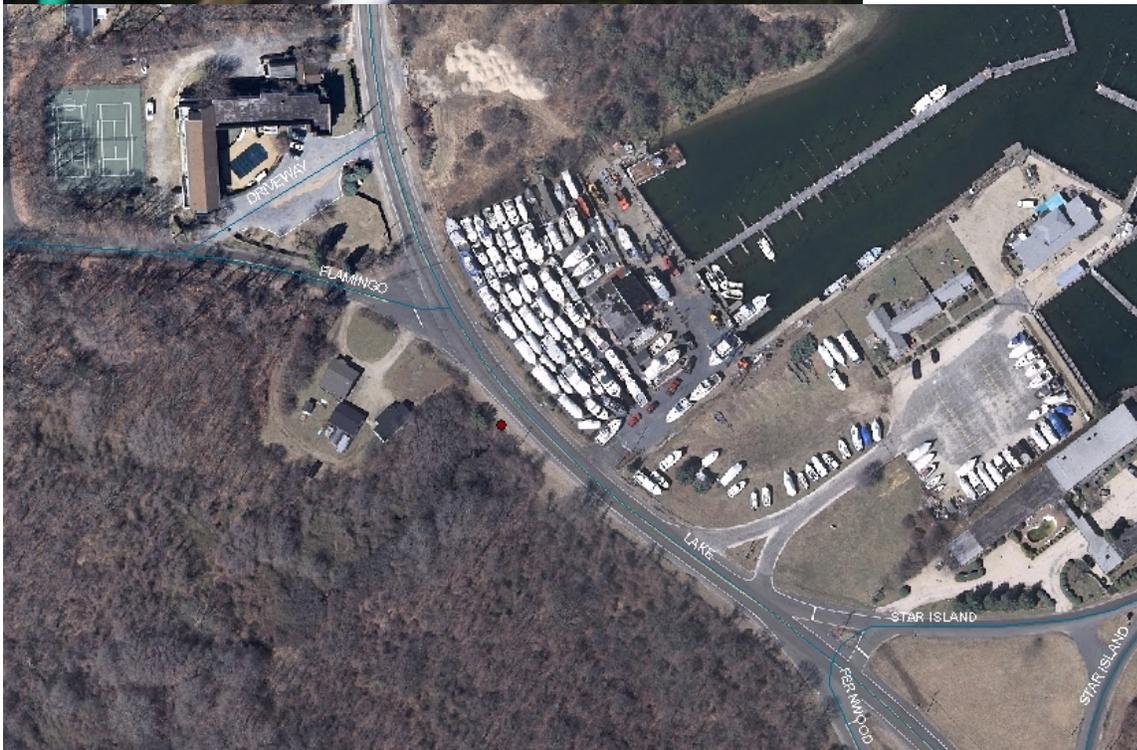
Aerial of Site 12. The red dot is of the pipe found across the street from the marina outfall

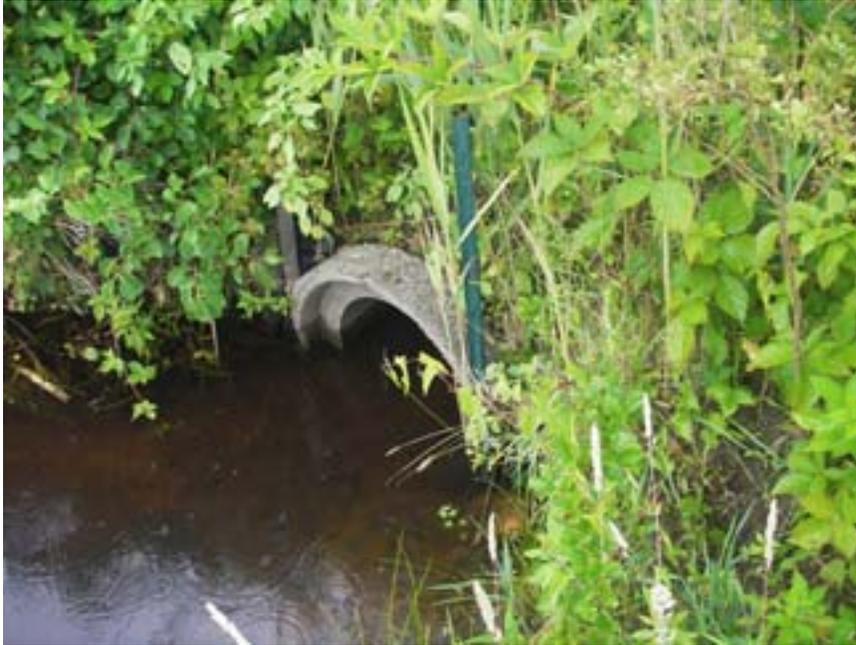
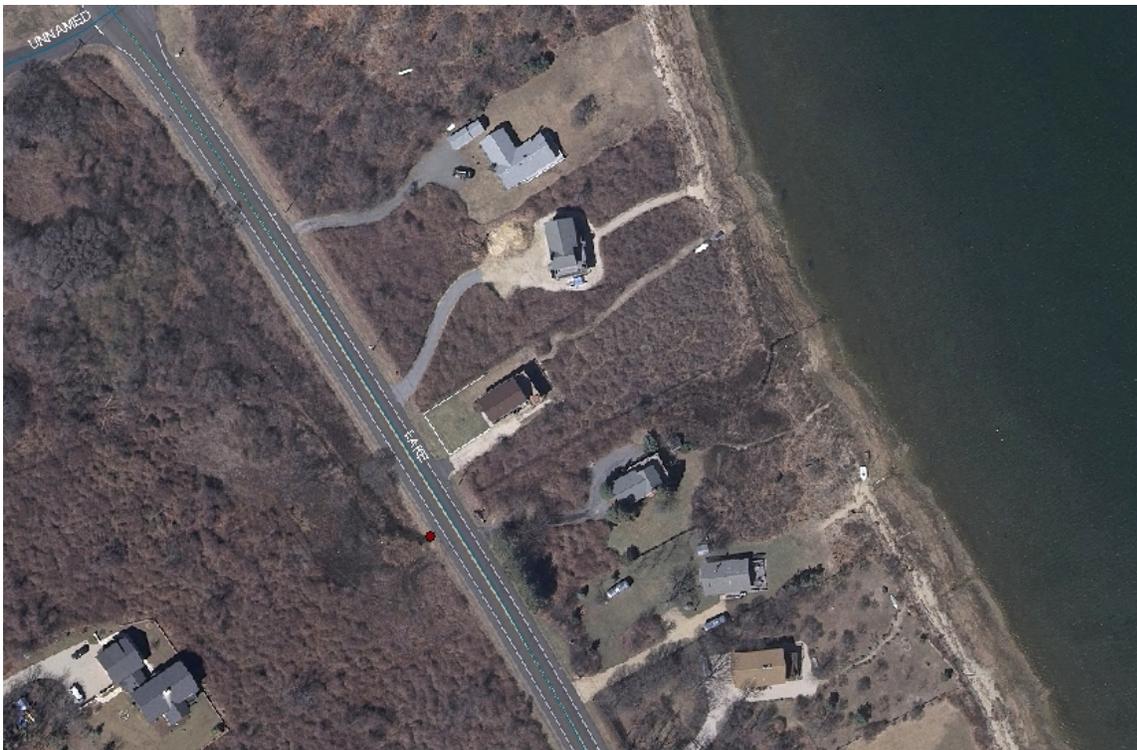
Aerial of Site 13

**Location & Pipe Description:** Outlet of the pond, located on the west side of the street. Pipe is 16 inches.

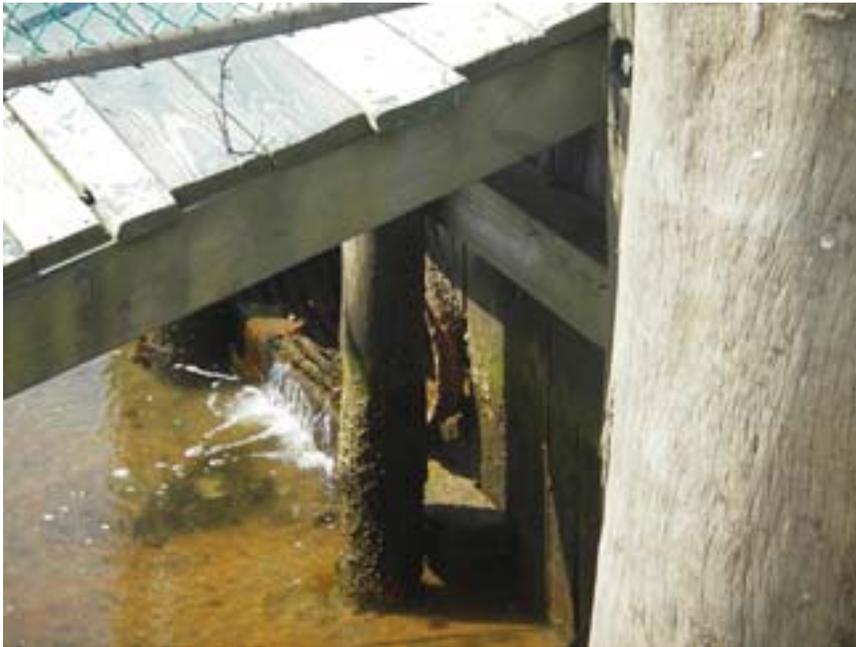
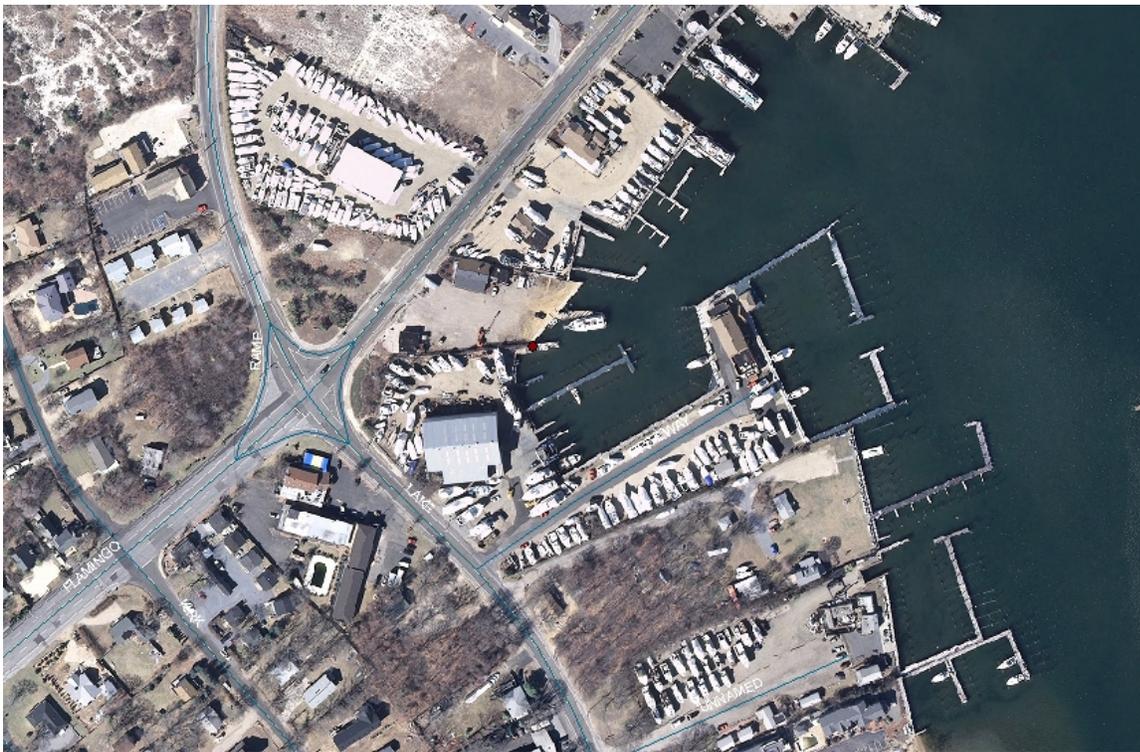
Aerial of Site 14

**Location & Pipe Description:** Pipe diameter is 4 ft. Discharges directly into lake from marina.

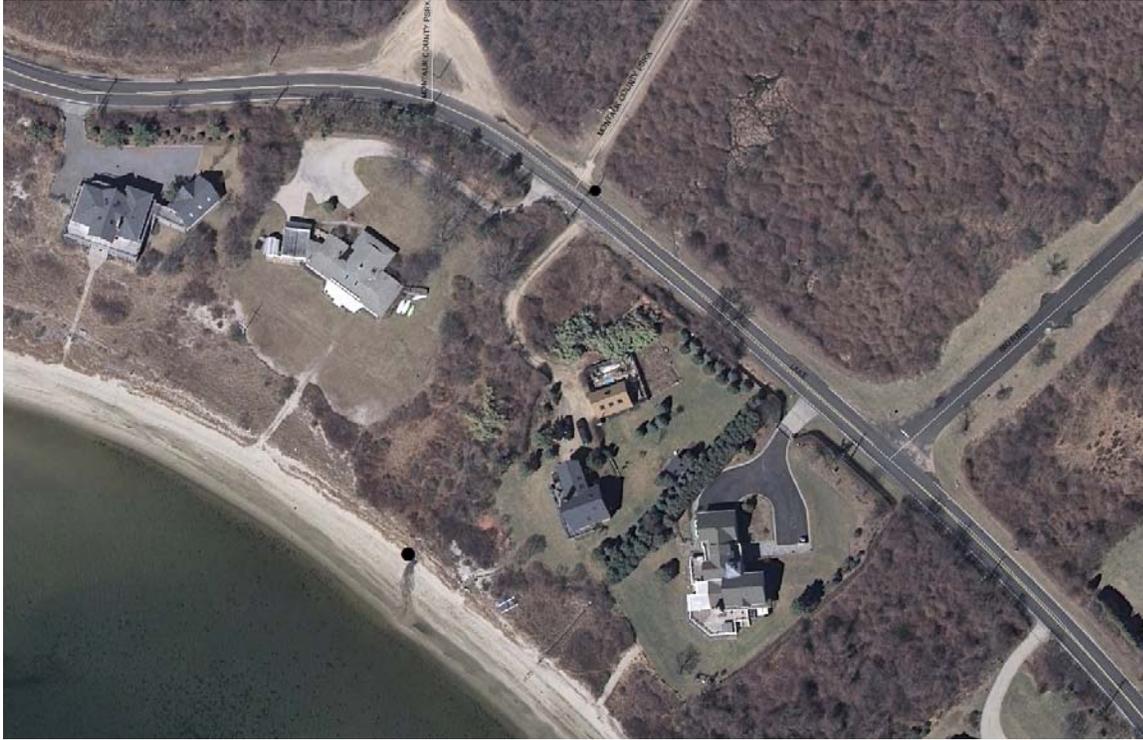
Aerial of 15B

**Location & Pipe Description:** Pipe diameter is 12 ft. Pipe runs from east side of East Lake Drive (15A) to outfall along beach (15B)

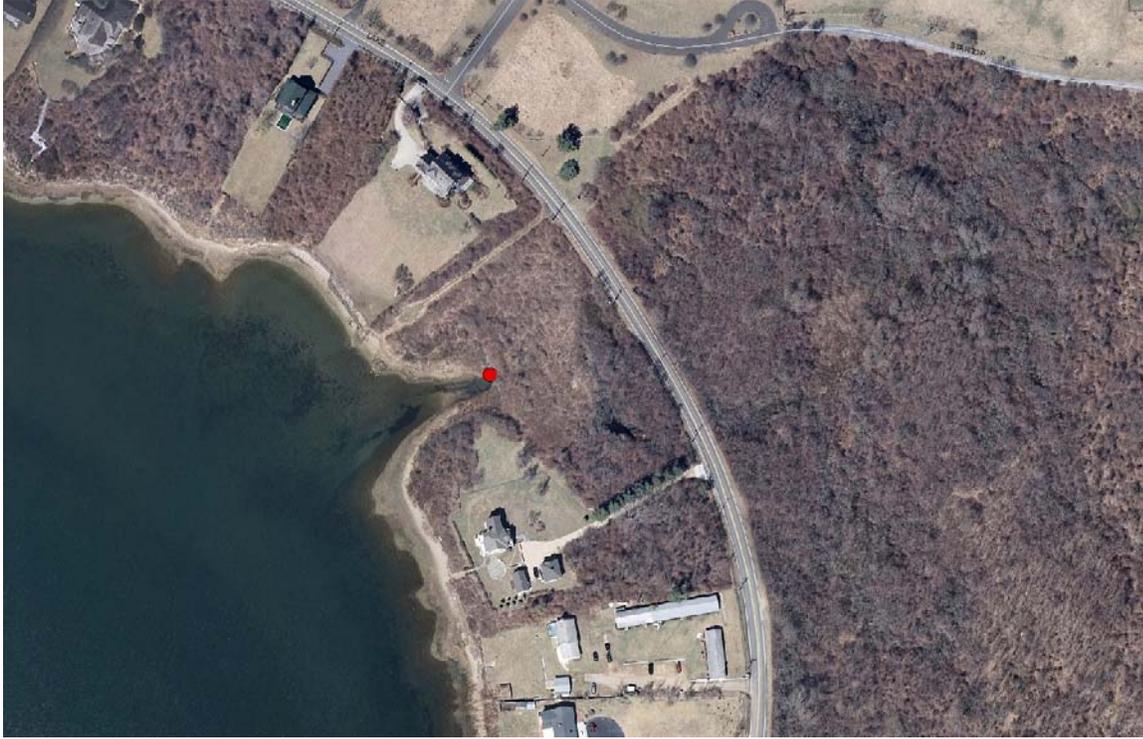
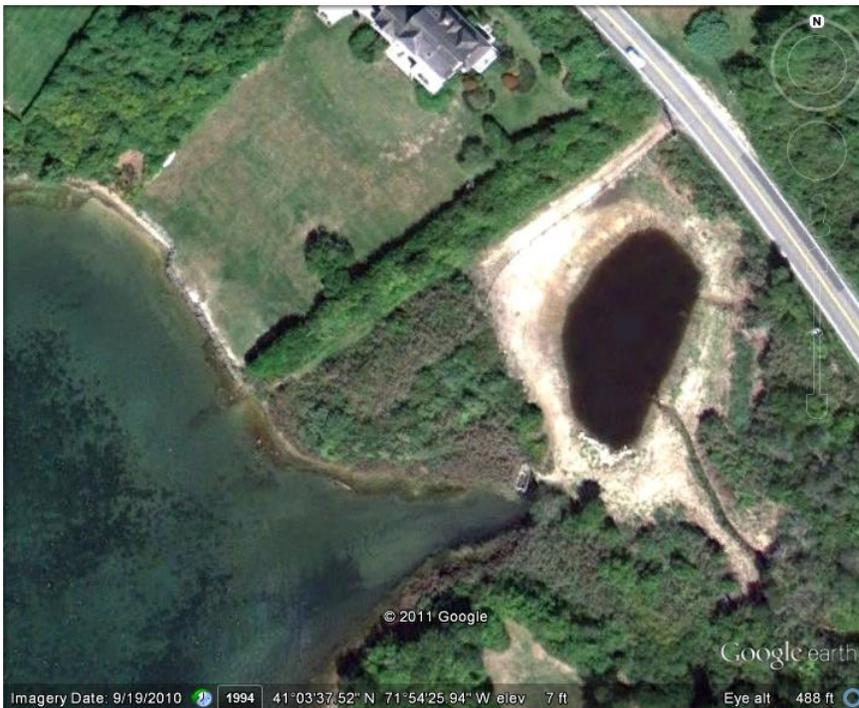
**Location & Pipe Description:** Pipe is located in a headwall. Retention Pond constructed June-July, 2010.

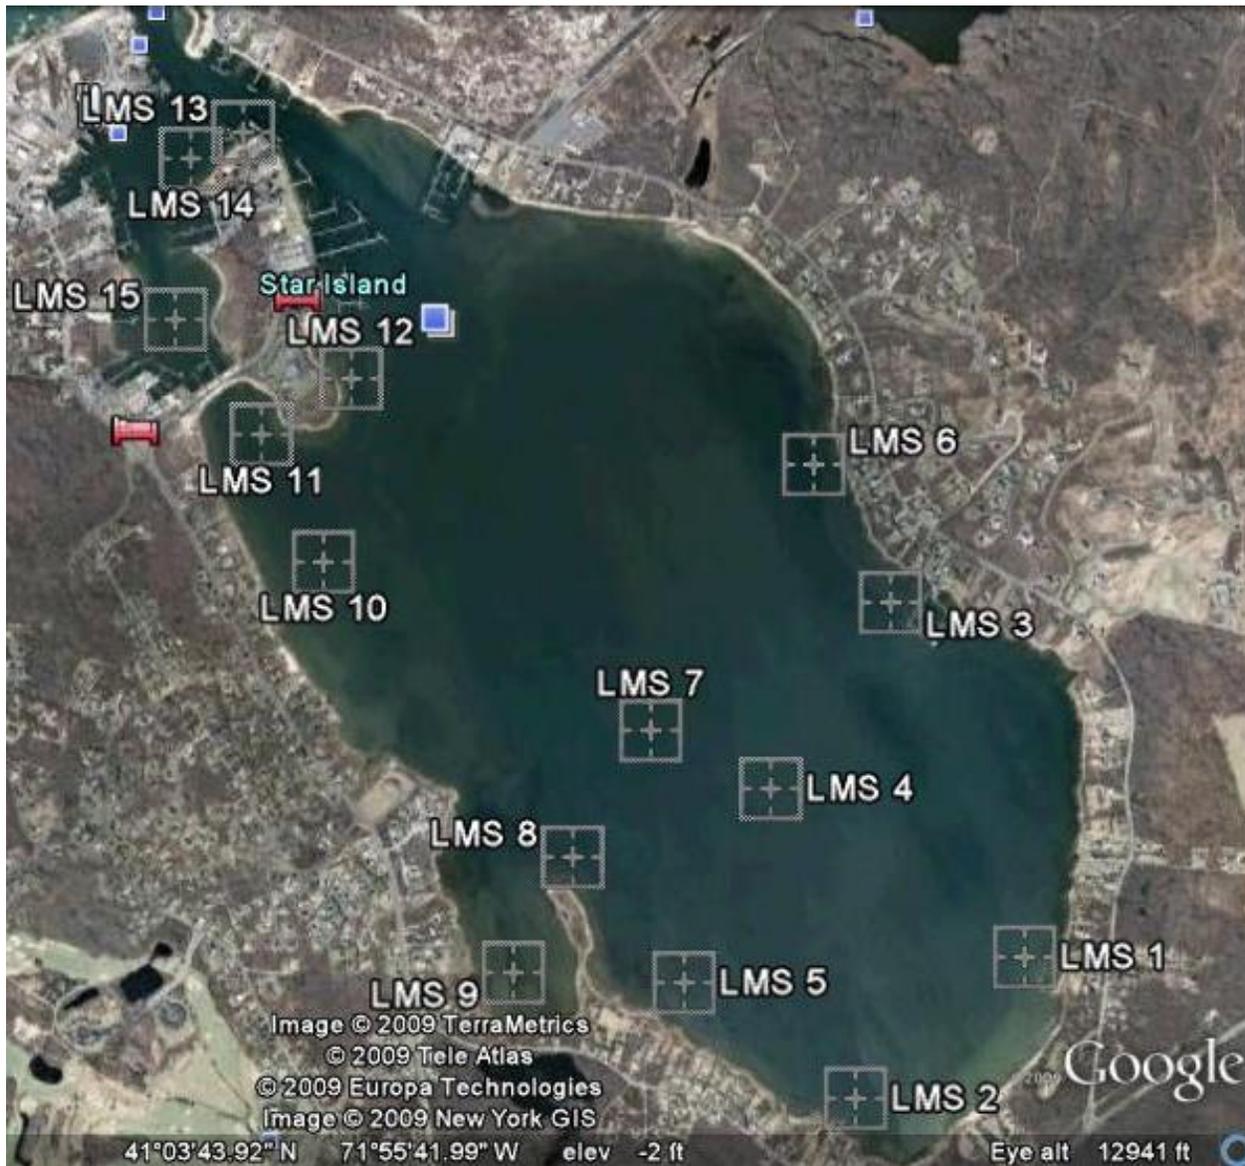
**Figure 1.** The sediment and infauna survey stations (LMS) for Lake Montauk.

Twenty stations were selected for sediment grain size analysis, percent organic matter and infauna analysis in Lake Montauk, East Hampton. All twenty stations were sampled between 23 September and 30 October 2008. Figure 1 shows the location of the 15 benthic infauna and sediment survey sites, while Figure 2 presents the stations established for the eelgrass eelgrass survey.

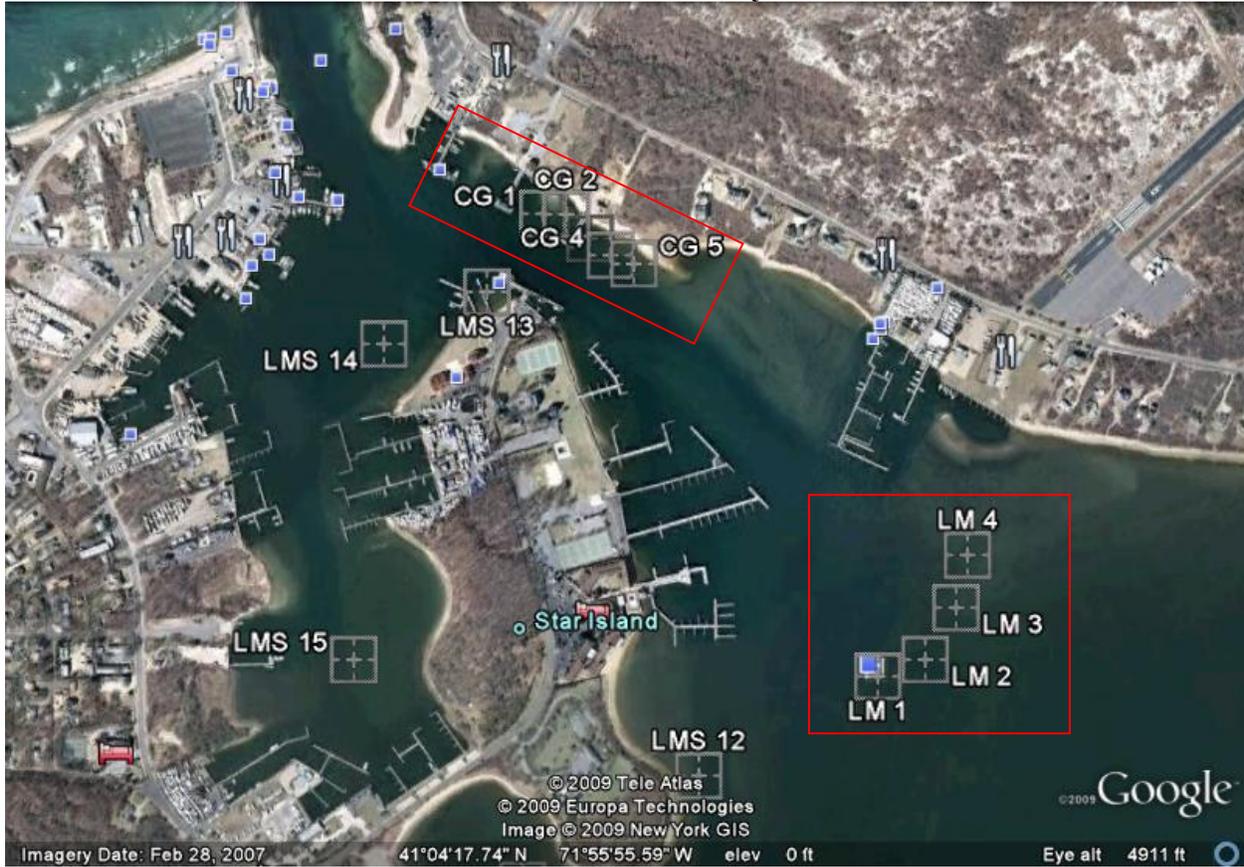
**Figure 2.** The eelgrass survey stations (Coast Guard [CG] and Lake Montauk [LM]), indicated within the red boxes, for the Lake Montauk Watershed Project.

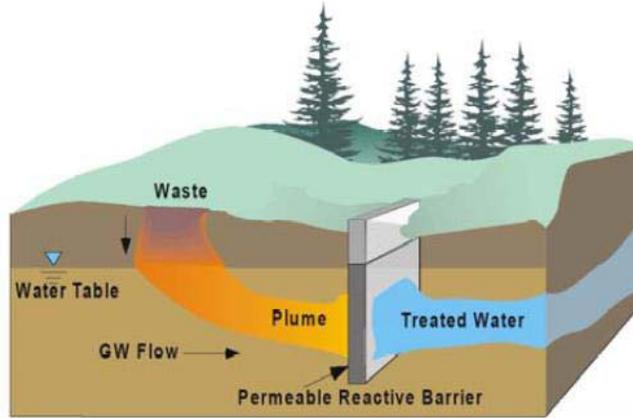
Figure 9: Permeable Reactive Barrier (Source: USEPA, 1998)

Costs for a PRB range from approximately \$5,000 to \$15,000 per dwelling unit in the plume area (EPA, 2010). The estimated lifetime of a PRB is greater than 15 years.

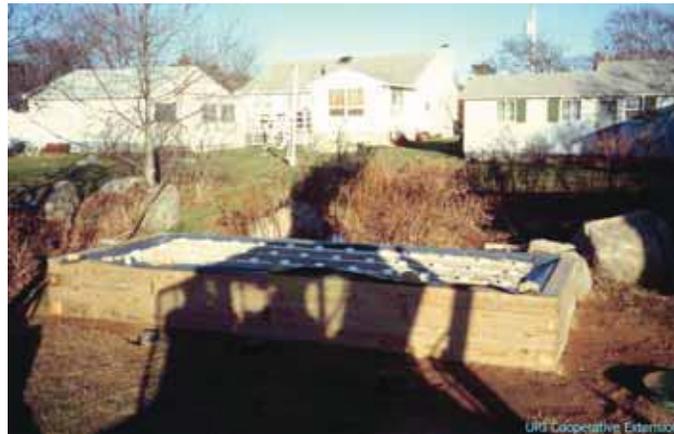
The media filter was selected for its small footprint and nitrogen reducing performance. The bottomless sand filter (Figure 4-3) was the only drainfield option available for this high water table site that provided bacterial reduction and avoided large amounts of fill material. This system significantly minimized site disturbance and surface topography changes that would have altered stormwater movement; at the same time it achieved a high degree of nitrogen reduction and moderate levels of bacterial reduction.

**Figure 4-3**  
**Bottomless Sand Filter Before the Final Cover of Peastone**

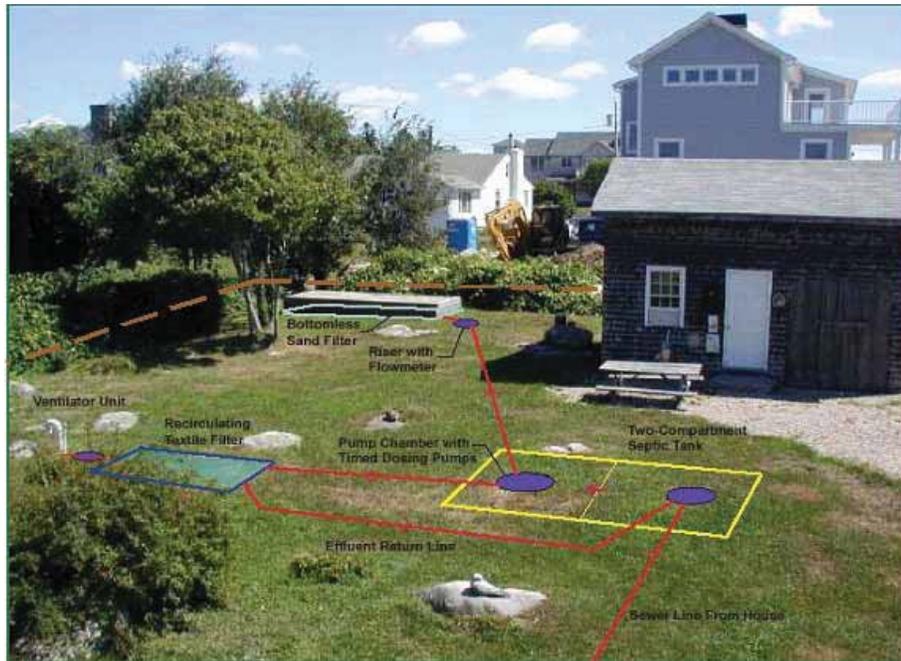
The alternative system fits into the landscape, amid boulders and trees while providing a much higher level of treatment than a conventional system (Figure 4-4).

**Figure 4-4**  
**The Alternative Treatment System's Layout Fits into the Landscape**
