## LAKE MONTAUK WATERSHED MANAGEMENT PLAN

**FINAL**

**December 2014**

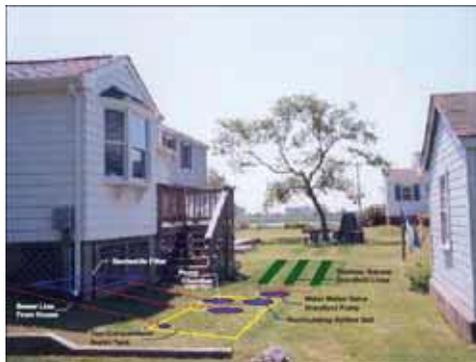
Wastewater from the home enters the septic tank, where it then recirculates to the media filter in the crawl space, then is dosed to the shallow narrow drainfield where additional treatment occurs (Figure 4-6). The coastal pond can be seen in the background of Figure 4-6, approximately 300 feet away. The recirculating media filter fits in the crawl space under the cantilevered room of the house (Figure 4-7). The owners of the white building seen beyond the outdoor stairs in Figures 4-6 and 4-7 later installed a similar system.

**Figure 4-6**  
**Locations of the Final System Components**

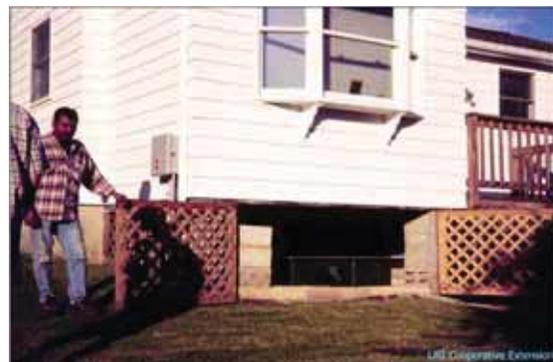
**Figure 4-7**  
**Recirculating Media Filter Under a Cantilevered Room**

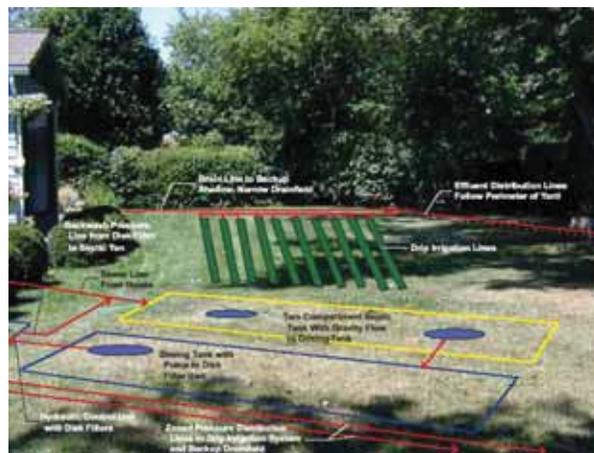
**Figure 4-8**  
**Drip-Irrigation System Layout for Turf and Landscape Maintenance**

One of the homeowner's main concerns was maintaining a vigorously growing turf on his landscaped lawn. To satisfy the owner's request, the system selected for this site was a septic tank followed by a pump tank that dosed a drip-irrigated field. The drip irrigation tubing was installed six inches below ground surface to maximize nutrient and moisture use by grass. Although the yard was large enough to accommodate most any technology, the drip irrigation fit well on the site because there was sufficient level space to accommodate the required amount of drip tubing. Figure 4-8 shows the location of the system components.

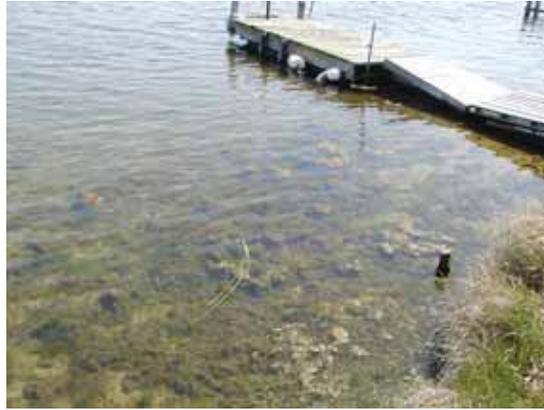
This real-world example site is located directly on the shore of a nitrogen-sensitive coastal pond that has been closed to shellfishing due to high bacteria levels. Nutrient enrichment at the shoreline of this property has caused an overabundant growth of nuisance algae (Figure 4-12).

**Figure 4-12**  
**An Overabundant Growth of Nuisance Algae**  
**Caused by Nutrient Enrichment**

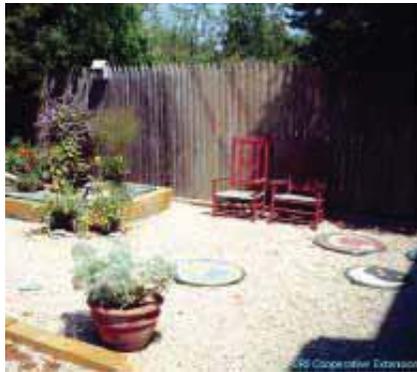
Figure 4-14 and Figure 4-15 show various views of the recirculating media filter system for this tight lot. One-half of the shallow narrow drainfield is located under the clothes line in between the home and the fence at the lot line (Figure 4-15).

**Figure 4-14**  
**Recirculating Media Filter System**  
**on a Small Lot**

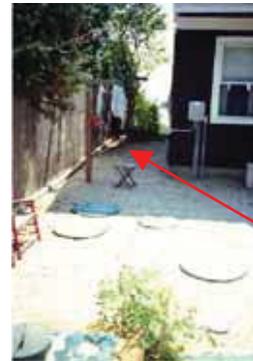
**Figure 4-15**  
**The System's Drainfield is Located**  
**Between the Home and the Fence**

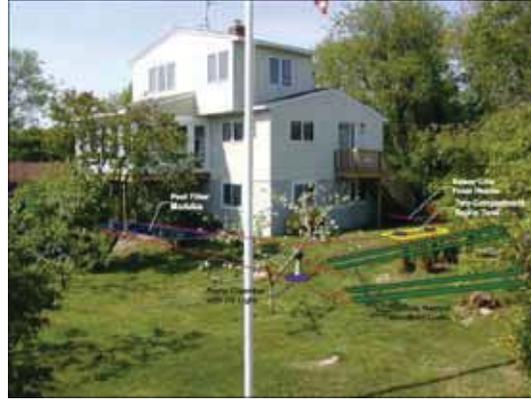
The technology selected was a septic tank with a pump dosing a single-pass modular media filter. Figure 4-17 shows the system layout. Wastewater from the house enters the septic tank (A) where effluent is dosed to the single-pass media filters (B) located under the deck. Treated wastewater flows through an ultraviolet light disinfection unit (C) and then is dosed to the shallow narrow drainfield (D) adjacent to an existing fern garden (Figure 4-18).

**Figure 4-18**  
**Locations of System Components on the Site**

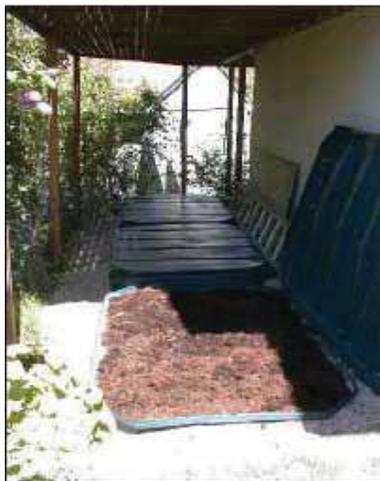
The media filters come in pre-packaged modular units that provide flexibility in siting, simplify installation, and enable limited site disturbance to the lot during construction (Figure 4-19). The UV light disinfection unit provides an additional level of bacterial removal to help reduce the pollution risk from this system. Due to the slope on this lot, a conventional system would have required extensive clearing with large amounts of machine time and gravel fill to enable level areas for drainfield lines, all with little nitrogen removal.

**Figure 4-19**  
**Modular Single-Pass Media Filters**

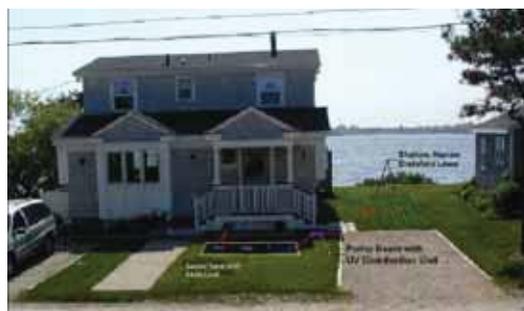
With remodeling, the footprint was slightly enlarged (Figure 4-21). The number of bedrooms remained the same, keeping potential occupancy at the same level and preventing an increase in nutrient loading.

**Figure 4-21**  
**Remodded House with a Slightly Enlarged Footprint**

Figure 4-23 shows the system layout. Wastewater from the house enters the septic tank (A) and flows through the fixed activated sludge system (B). Treated wastewater flows through an ultraviolet light disinfection unit (C) and then is dosed to the shallow narrow drainfield (D). Figure 4-21 also shows the location of system components.

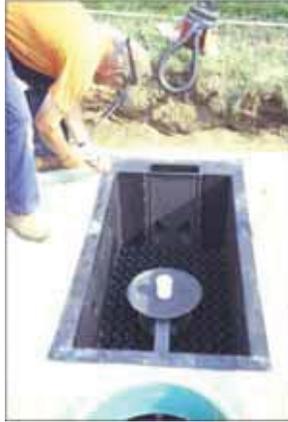
To meet the space and treatment demands of this site, a system incorporating fixed activated sludge technology was installed. This is a space-saver system because the treatment unit itself actually rests within the septic tank (Figure 4-22), eliminating the need for separate space to fit the treatment unit.

**Figure 4-22**  
**The Treatment Unit**

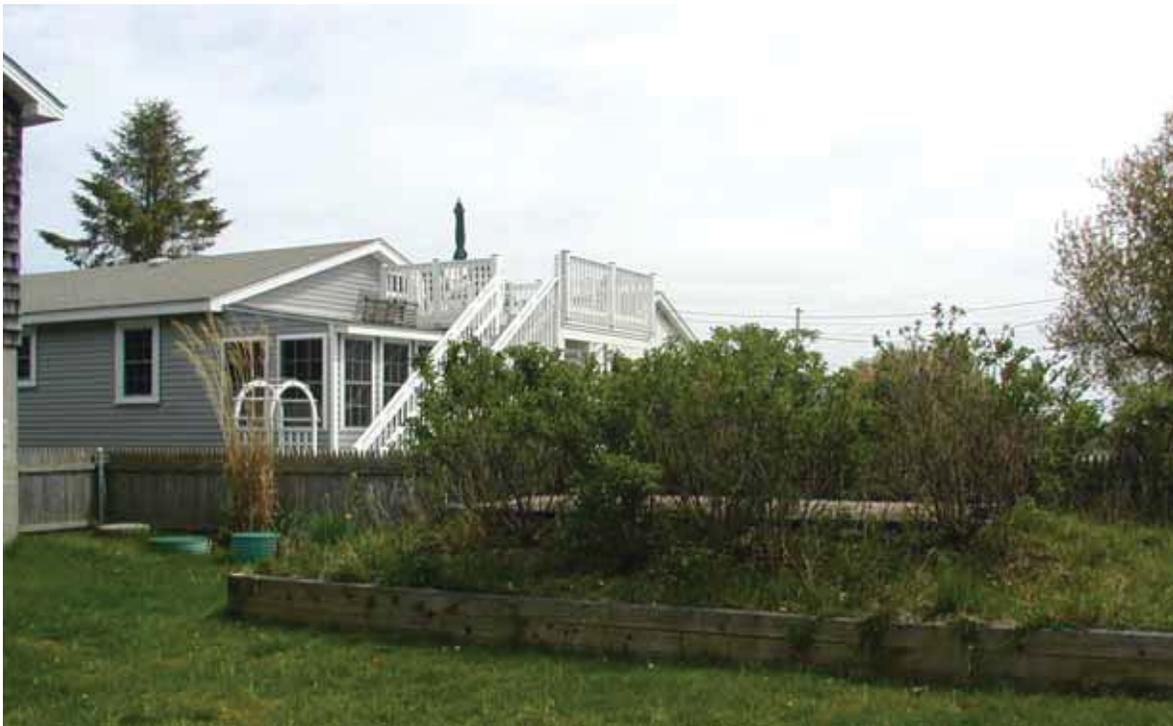
On this small flat coastal plain lot located in the watershed of a nitrogen-sensitive coastal pond, a recirculating media filter was installed to achieve a state-imposed discharge standard of at least 50 percent total nitrogen reduction. Although this technology was a good choice for this area from a treatment and space allocation perspective, the designer insisted on using a conventional (gravity-fed) drainfield. The media filter serves the house on the left in Figure 4-24 (only a corner is barely visible) the fence behind the tank and filter marks the adjoining property boundary with the house in the background.

**Figure 4-24**  
**Single-Family Home With a Raised Recirculating Media Filter and Conventional Gravity-Flow Drainfield**

The recirculating media filter, which is raised well above the original ground surface and landscaped with native shrubs, uses up more space than actually needed. The raised area effectively limits the owner's use of that portion of the property and creates an aesthetic issue (in this case with several neighbors).

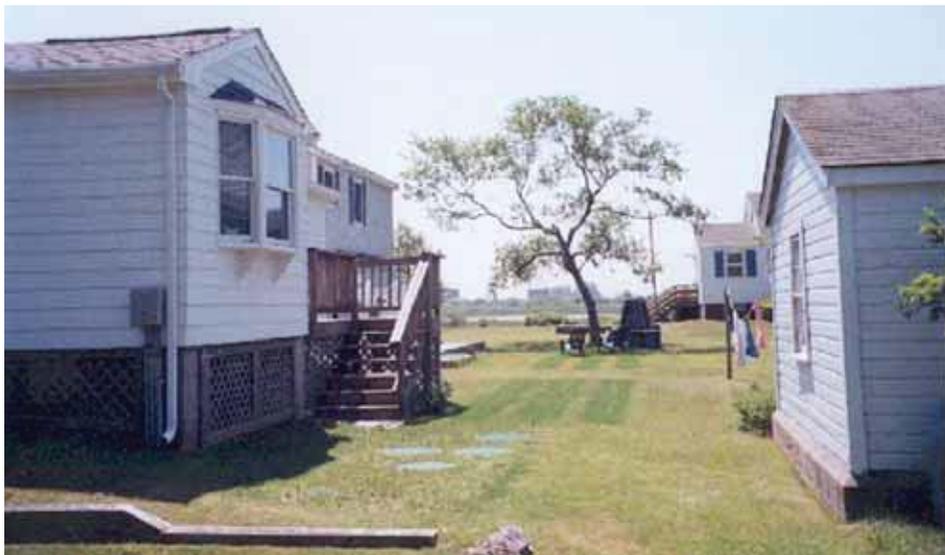
**Figure 4-25**  
**A Conscientious Installer Paid Careful Attention to Details and Lined Up the Drainfield Lines on These Two Separate Lots to Produce a More Orderly and Aesthetically Pleasing Look**

An important consideration when selecting a treatment system is how the system will blend in with surrounding properties. Figure 4-25 shows a site with a demonstration system (foreground) with a shallow narrow drainfield—apparent by the greener grass.

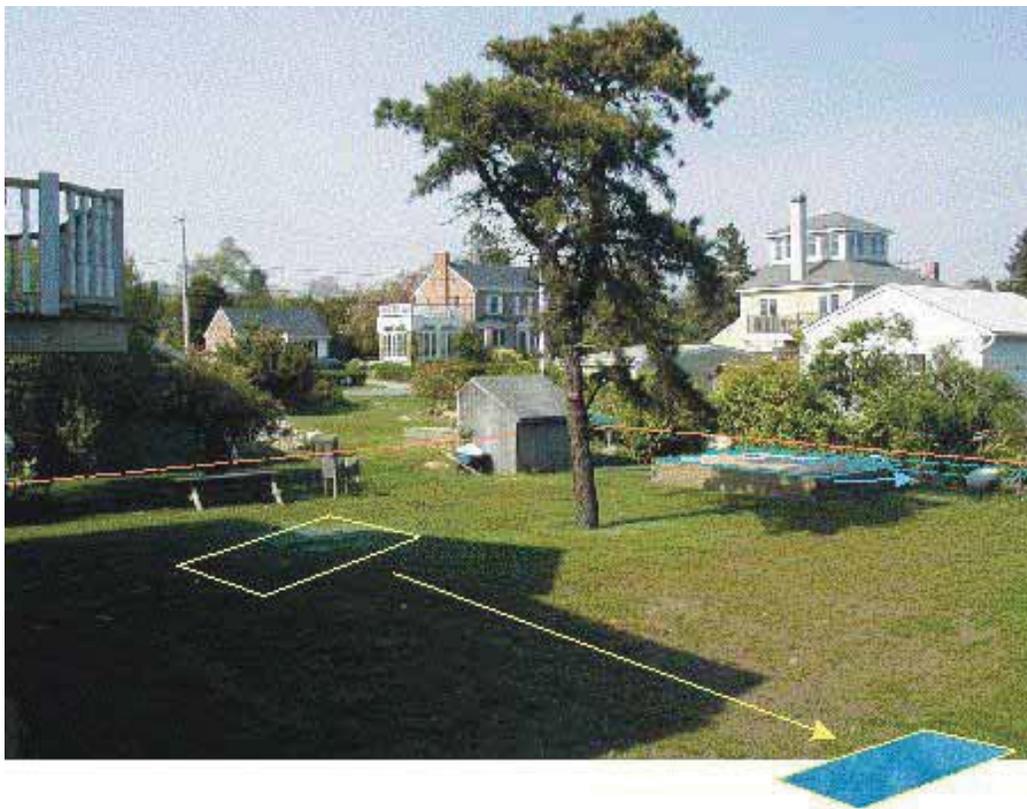
**Figure 4-26**  
**An Example of Component Placement Options**

Two adjoining lots in a coastal pond neighborhood upgraded failed septic systems using advanced decentralized treatment systems. Recirculating media filters followed by bottomless sand filter drainfields were used on each lot to achieve nitrogen and pathogen removal, fit on a small lot, and accommodate high water table conditions. The orange line shown in Figure 4-26 marks the property boundary, the treatment unit is outlined in yellow, and the bottomless sand filter is on the right of the pine tree.

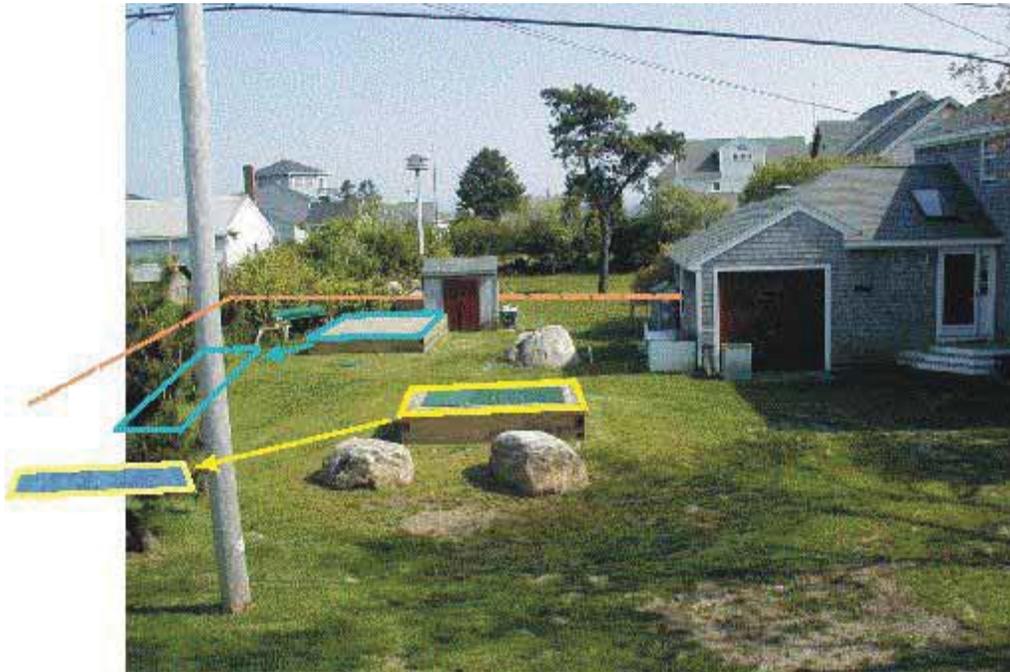
In the adjoining lot (Figure 4-27), similar redesign would have enabled greater use of the property and avoided the need for costly landscaping to camouflage treatment units. The property boundary, as shown by the orange line, extends beyond the photo to the left, with space at the corner of the property, left of the telephone pole, for the treatment unit. The bottomless sand filter, located in front of the shed at the rear of the property, currently blocks the shed door, preventing it from opening fully. The bottomless sand filter could have been designed in a long rectangular shape and sited along the hedge following the property boundary on the left.

**Figure 4-27**  
**An Additional Example of Component Placement Options**

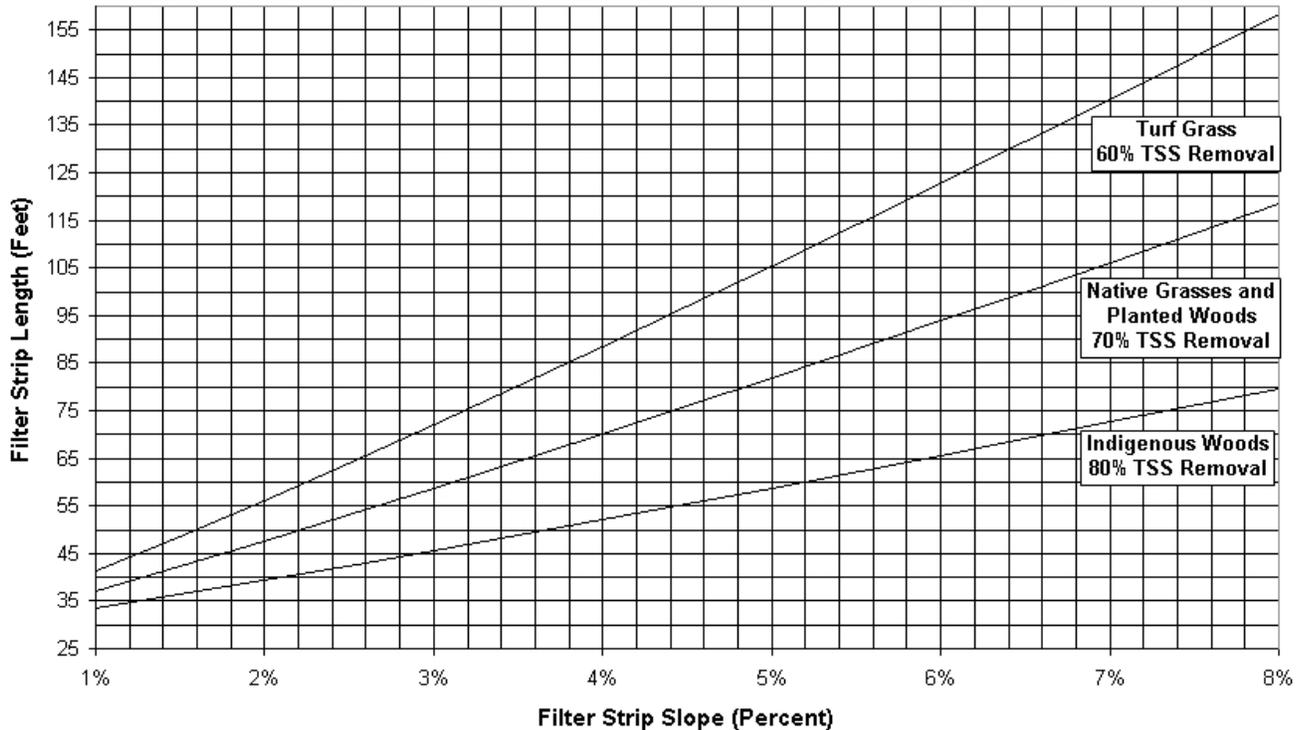
**Figure 9.10-6: Vegetated Filter Strip Length**  
**Drainage Area Soil: Clay Loam, Silty Clay, Clay HSG: D**

To achieve the adopted TSS removal rates shown above in Table 9.10-1, the required filter strip length can be determined from Figures 9.10-2 to 6 below based upon the filter strip’s slope, vegetated cover, and the soil within its drainage area. As shown in the figures, the minimum length for all vegetated filter strips is 25 feet.

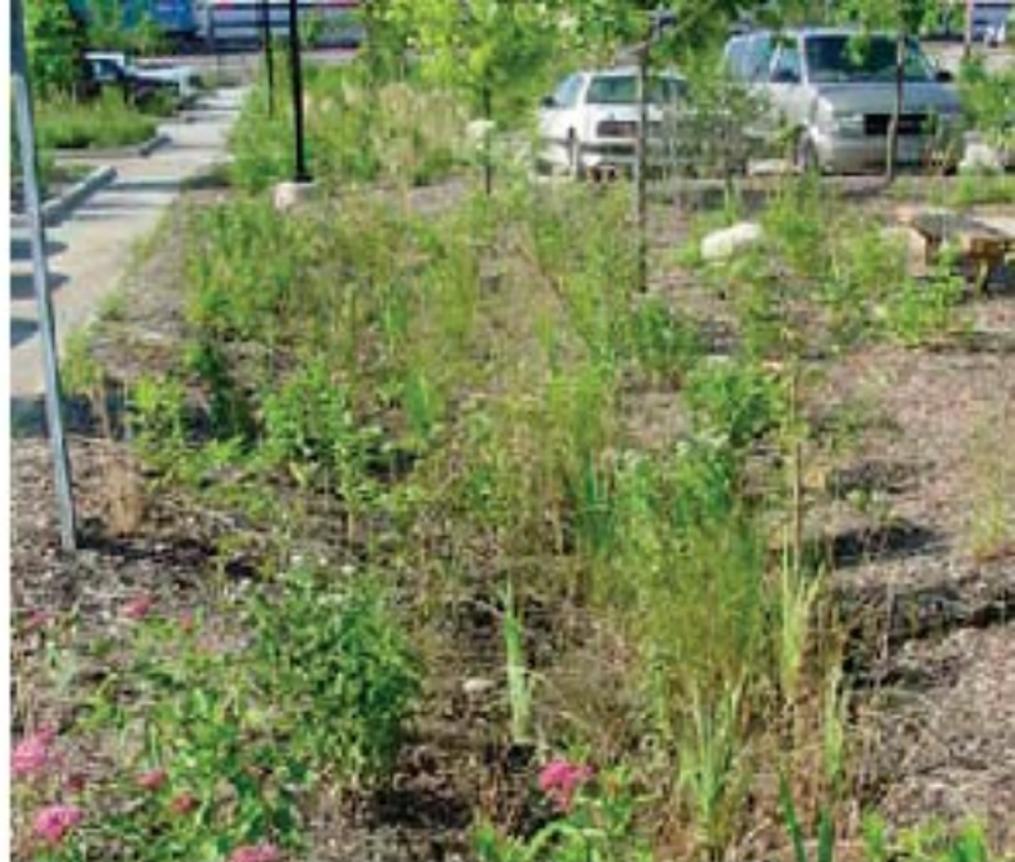
The Chicago Center for Green Technology uses filter strips to convey runoff on-site.

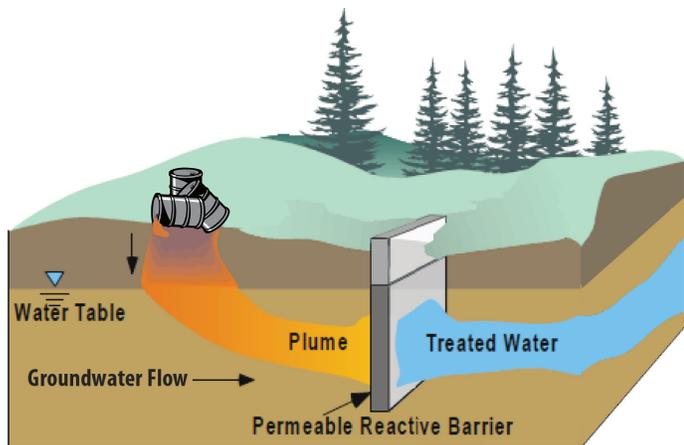
PRB treats a plume of groundwater contaminants.

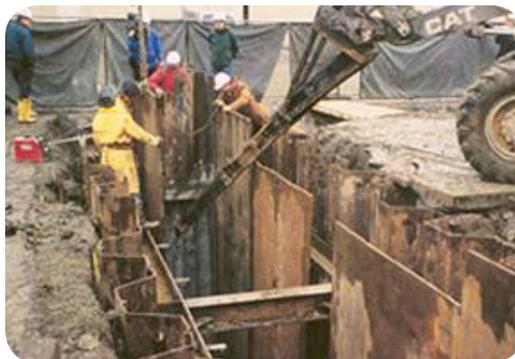
*Construction of a PRB in Sunnyvale, CA*

A PRB is usually built by digging a long, narrow trench in the path of contaminated groundwater flow. The trench is filled with a reactive material, such as iron, limestone, carbon, or mulch, to clean up contamination. Due to limitations of excavation equipment, walls typically can be no deeper than 50 feet. However, a deeper but usually shorter PRB can be built by drilling a row of large-diameter holes or by using fracturing (See *A Citizen's Guide to Fracturing* [EPA 542-12-008]) and other new techniques.

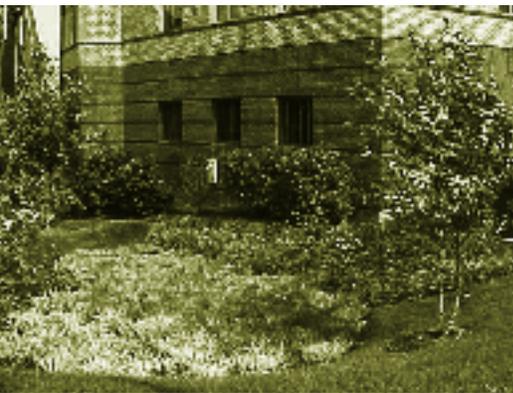
Above: This bioretention cell at a office park also helps to fulfill site landscaping requirements. *Photo: Low Impact Development Center*

Right: This schematic diagram shows parking lot runoff directed to a bioretention cell, with pretreatment by a grassed filter strip.

Bioretention cells are usually excavated to a depth of 4 feet, depending on local conditions. Generally, cells should be sized (based on void space and ponding area) to capture and treat the water quality volume (the first 0.5” or 1” of runoff, depending on local requirements.) Some manuals suggest a minimum width of 15’, though much narrower bioretention cells have been installed in parking lot islands and are functioning well. Regardless of size, some type of filter should cover the bottom of the excavation. Filter fabric is commonly used but can be prone to clogging; consequently some engineers recommend a filter of coarse gravel, over pea gravel, over sand.

The cell should be filled with a soil mix of sandy loam or loamy sand. The area should be graded to allow a ponding depth of 6-8 inches; depending on site conditions, more or less ponding may be appropriate. The planting plan should include a mix of herbaceous perennials, shrubs, and (if conditions permit) understory trees that can tolerate intermittent ponding, occasionally saline conditions (due to road salt), and extended dry periods. The soil should be covered with 2-3” of fine-shredded hardwood mulch.

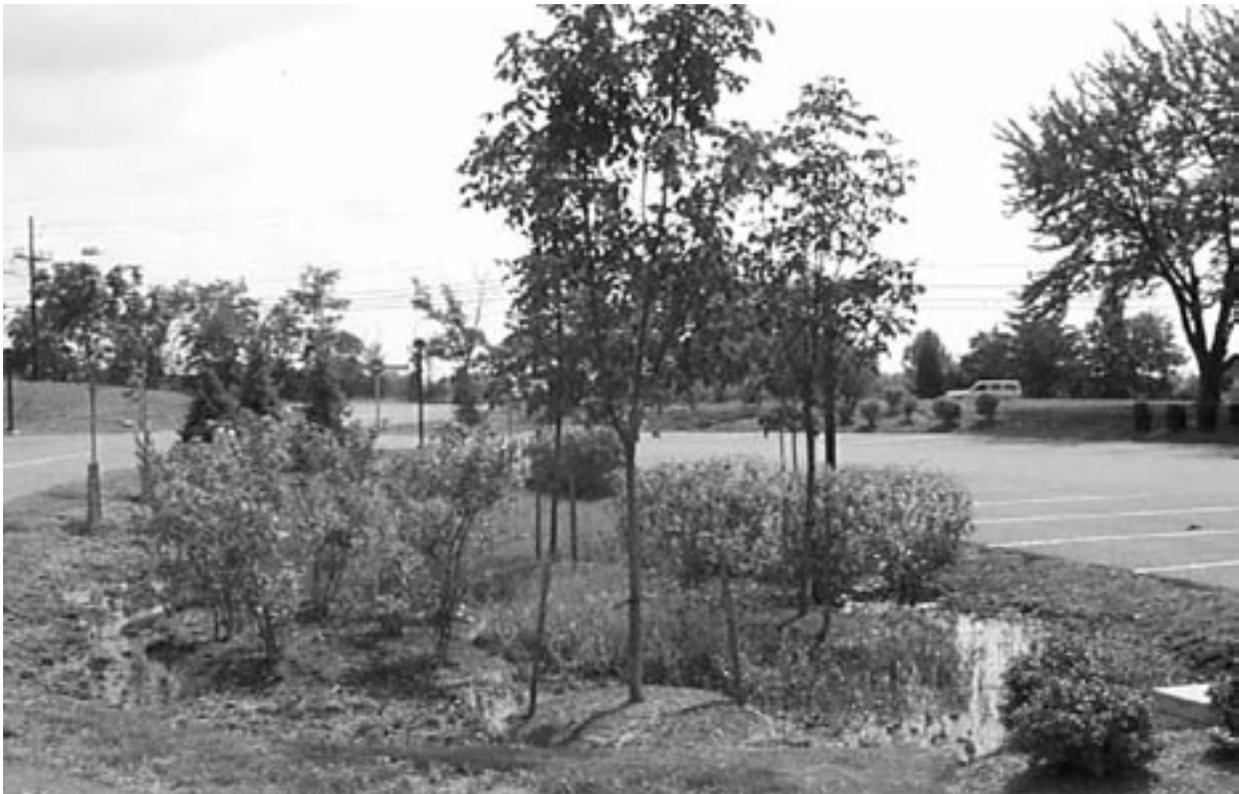
Above, top: Bioretention cells are designed to allow ponded water six inches deep, which should infiltrate into the ground within 72 hours after a storm.

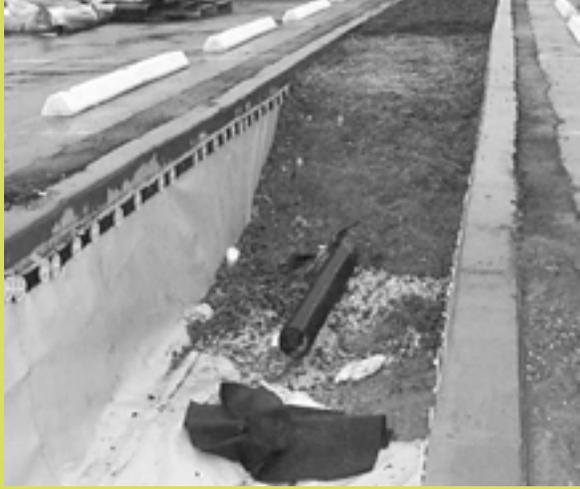
This parking lot bioretention cell is being constructed with an impermeable liner and a perforated underdrain, to provide retention and treatment of runoff (but not infiltration).

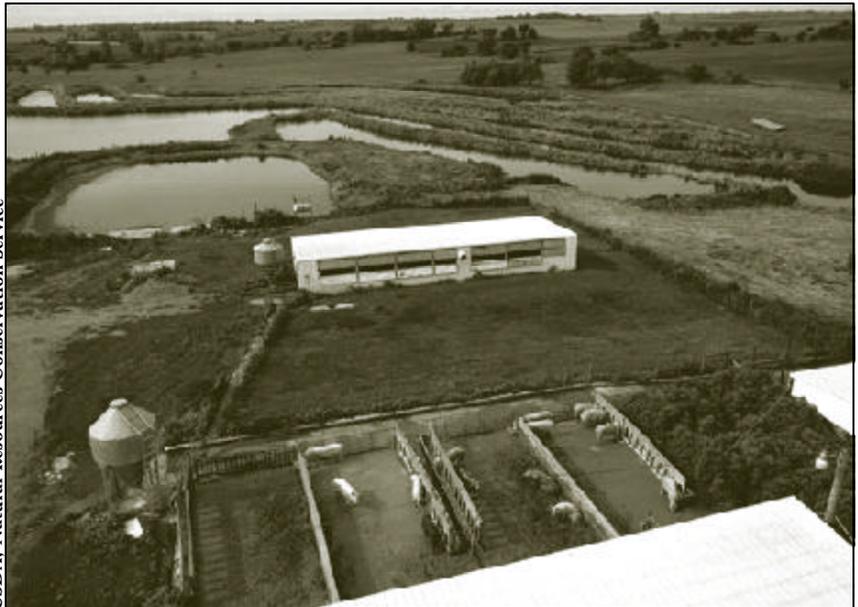
This hog operation in Taylor County, Iowa, uses a wetland system constructed on a series of hillside terraces to filter and purify wastewater. Water quality tests indicated that the effluent from the treatment wetland was cleaner than that required for wastewater treatment plants.

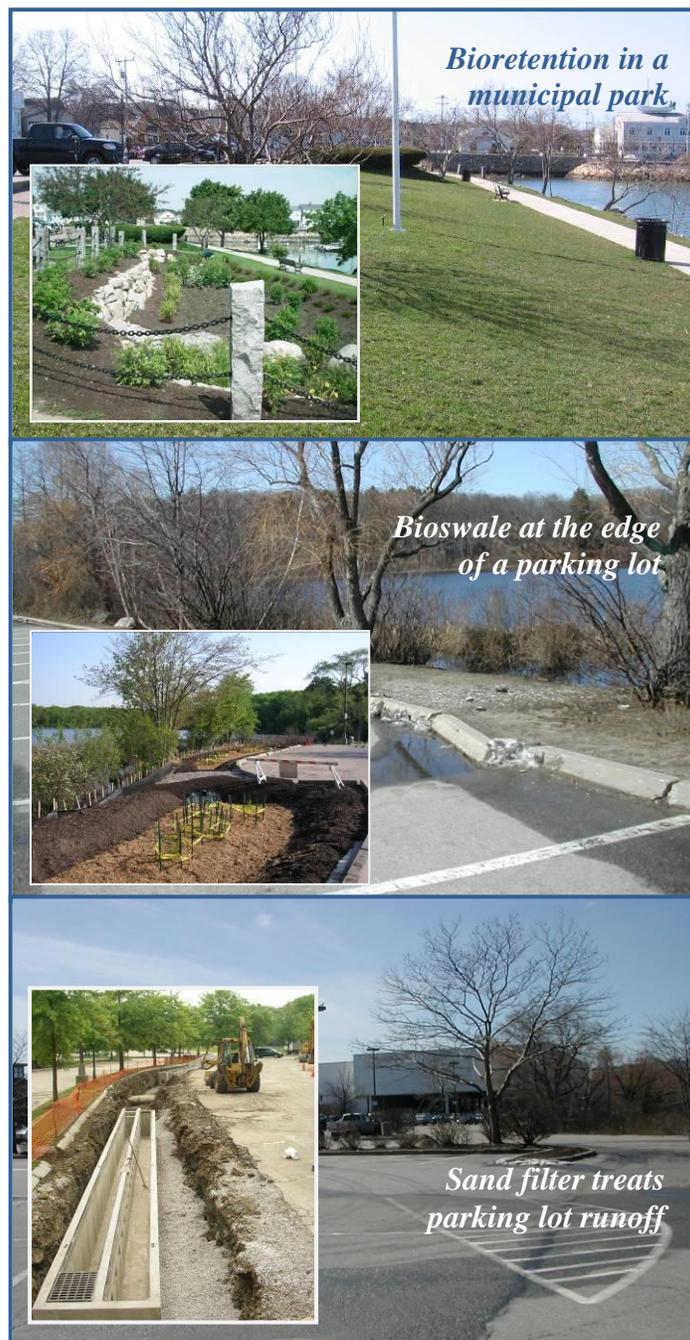
**Figure 1.** Structural retrofits such as the bioretention, bioswale, and sand filter shown here can be used to capture, treat, and/or infiltrate unmanaged runoff. Public open space and large parking lots are common retrofit locations.

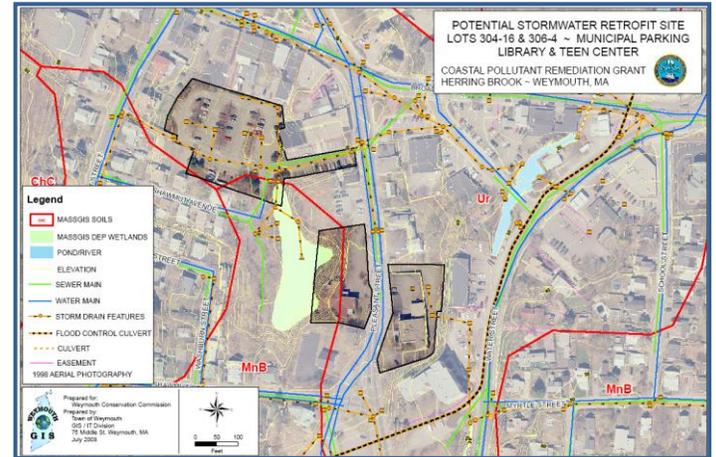
**Figure 2.** Mapping analysis used to identify potential locations for retrofits in Weymouth, MA showing aerial imagery, parcel ownership, stormwater infrastructure and utilities, topography, soils, and hydrology. The MassGIS and NH’s GRANIT websites are good sources of GIS data and can be found at [www.mass.gov/mgis/](http://www.mass.gov/mgis/) and [www.granit.unh.edu/](http://www.granit.unh.edu/), respectively.

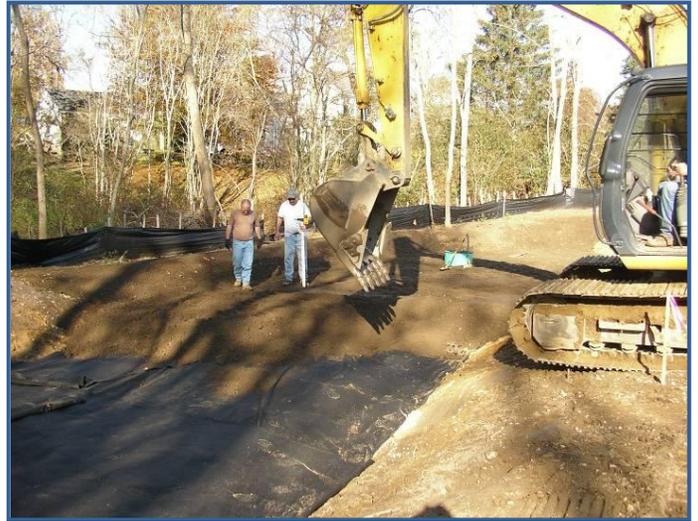
**Figure 4.** As an example of a priority retrofit taken to final design and construction, this shows the installation of a bioretention facility at a nature center in Massachusetts.

**7** Take the top projects to final design and construction stages (**Figure 4**). Allow additional time to complete site surveys, necessary state and local permitting, contractor bidding and specifications, and, in some cases, generate public support. The time required to secure implementation funding will likely vary depending on the primary source of funds (i.e., stormwater utility, general or capital budgets, or grants).

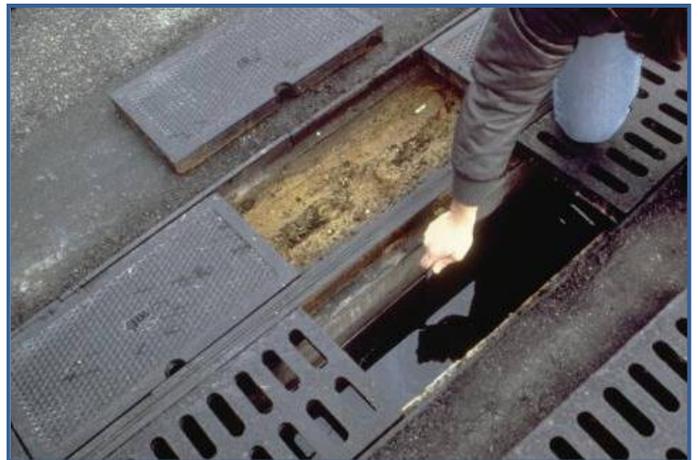
**Figure 5.** Ensuring the long-term maintenance of sand filters, swales, bioretention facilities, and other BMPs is a critical component of a municipal stormwater management program.

**8** Provide inspection and maintenance services for the life of the retrofit (**Figure 5**). MS4 programs should establish a BMP tracking system to ensure long-term maintenance of existing and retrofitted facilities.
